National Register of Historic Places
Inventory—Nomination FormSee instructions in *How to Complete National Register Forms*
Type all entries—complete applicable sections**1. Name**

historic Security Building

street & number 117 N. E. 1st Avenue

city, town Miami

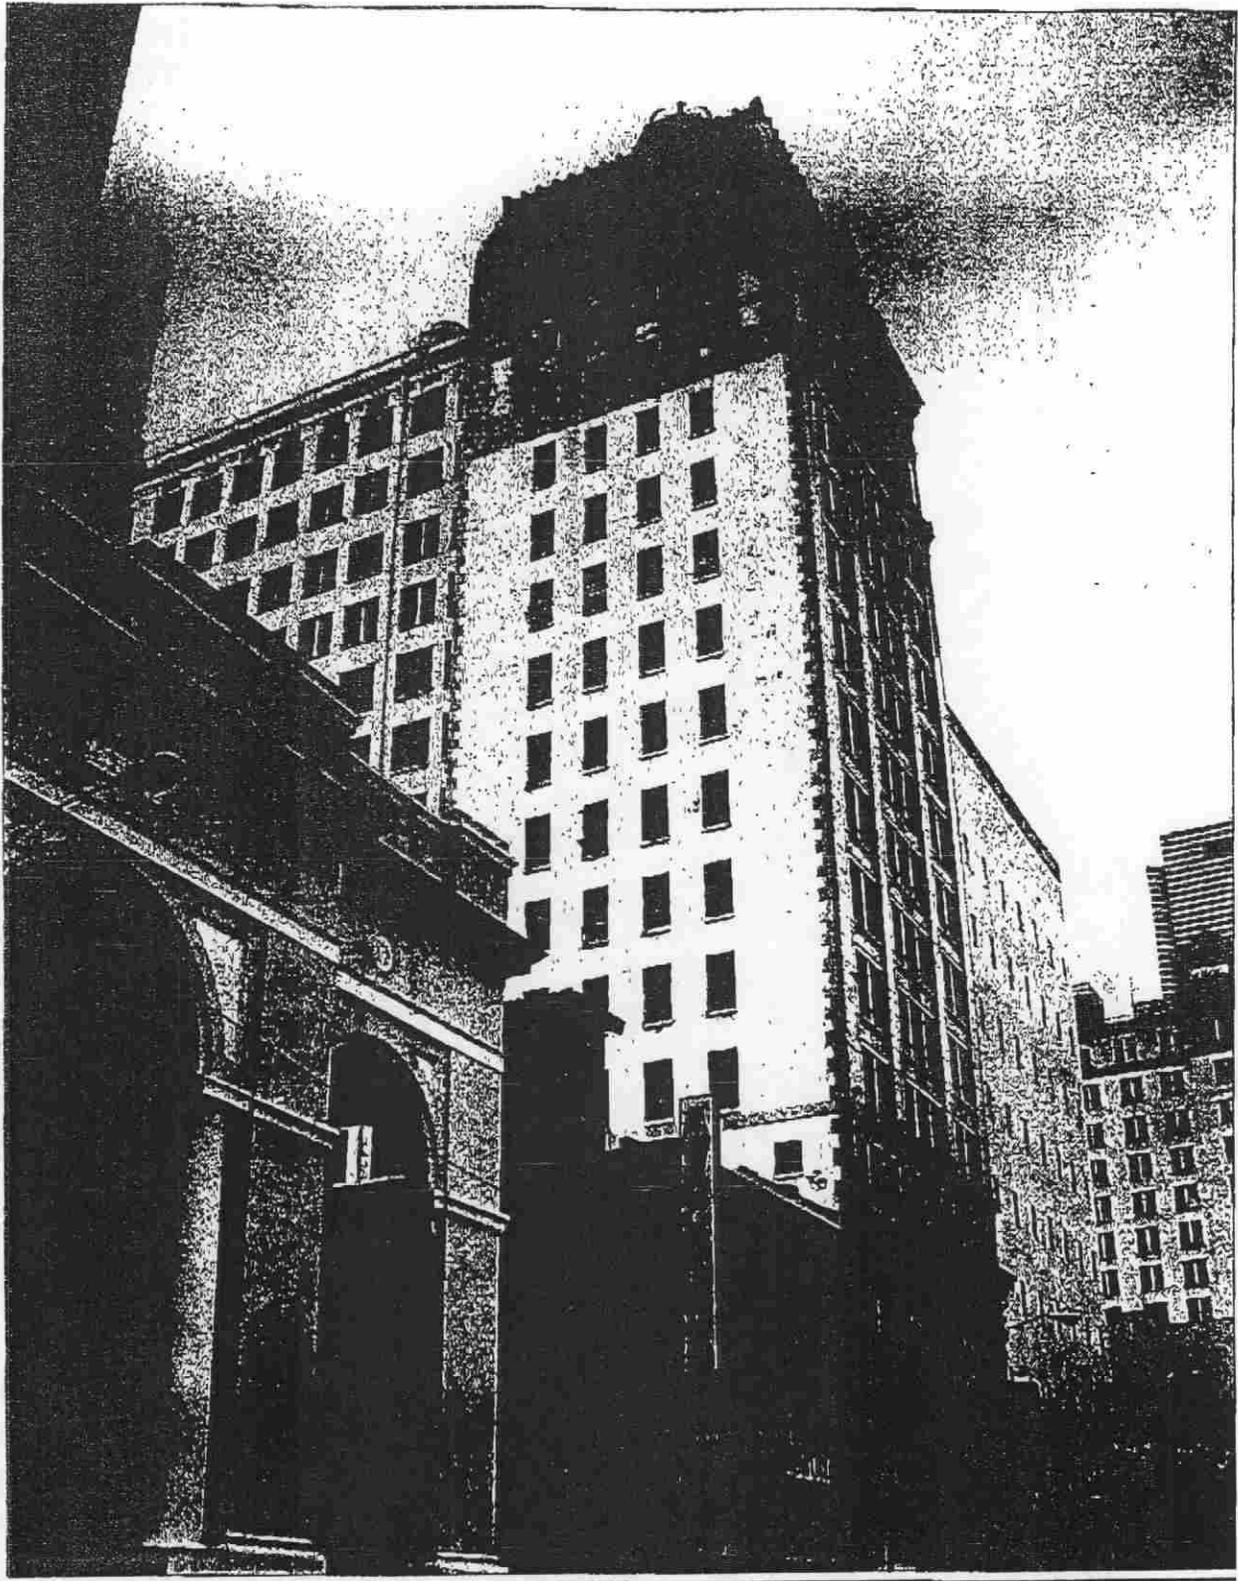
Security Building
117 NE 1st Avenue
North and west (front) façades
2002

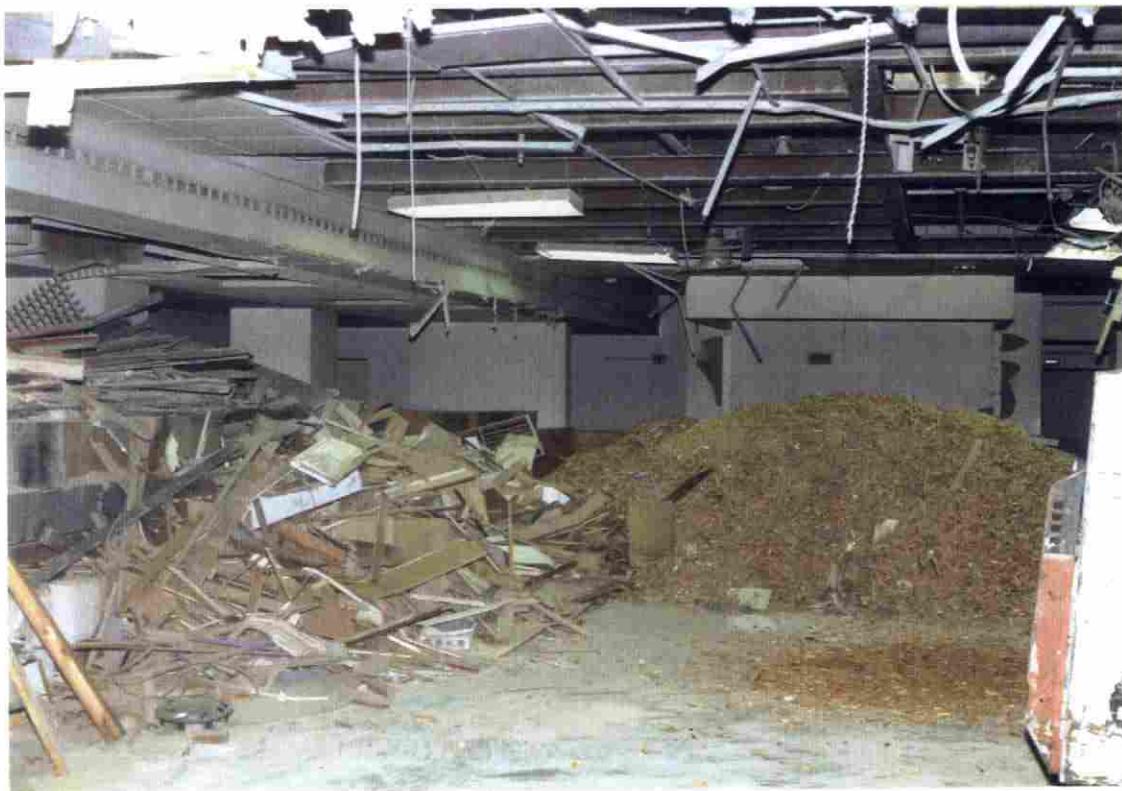
Security Bldg. Photo no.1
Ground floor
Non-historic ceiling &
steel support (I-Beams)
Mezzanine Area 7-12-00

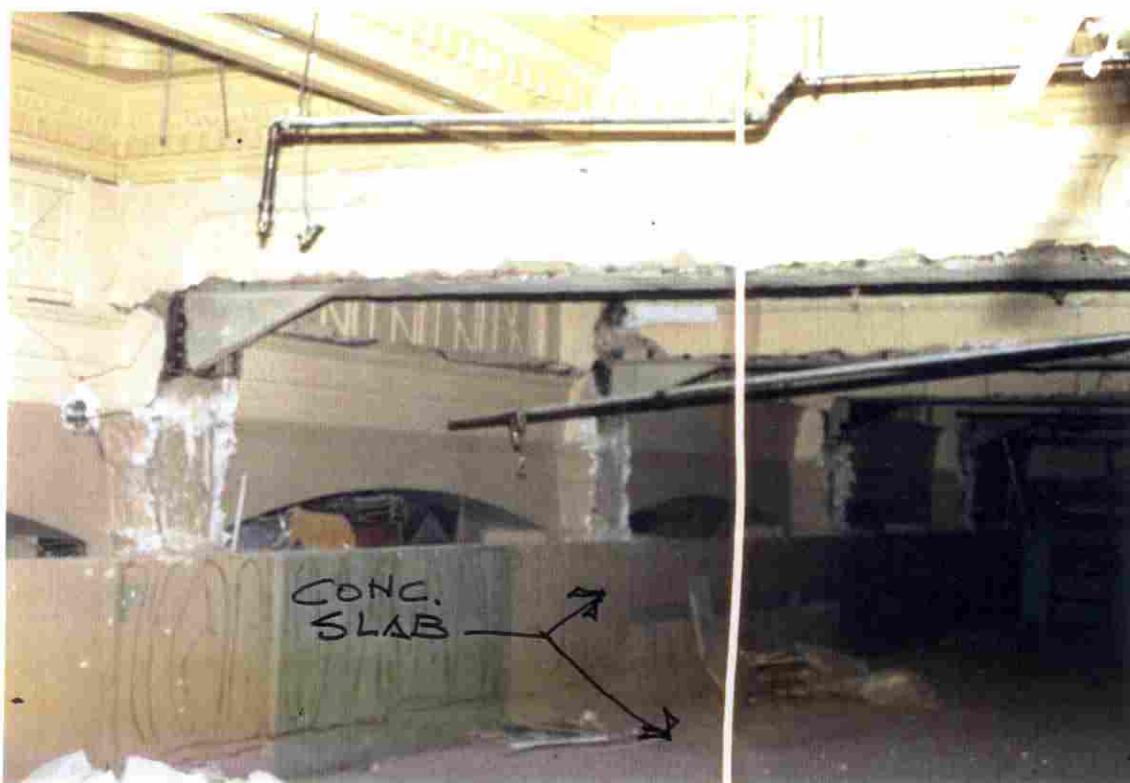
Security Bldg. Photo no.2
Mezzanine Level - 2nd floor
Non-historic concrete
slab/wall 7-12-00

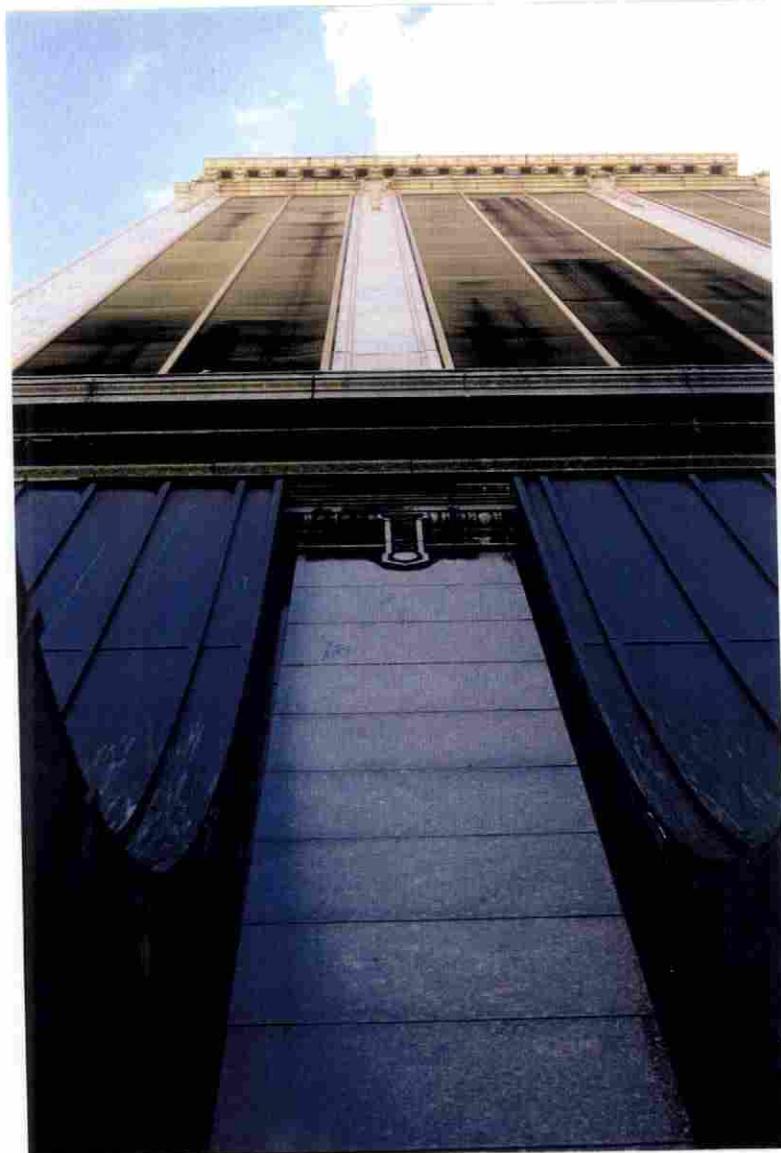
Security Building photo no. 5A
West Facade, non original metal
screen and awnings

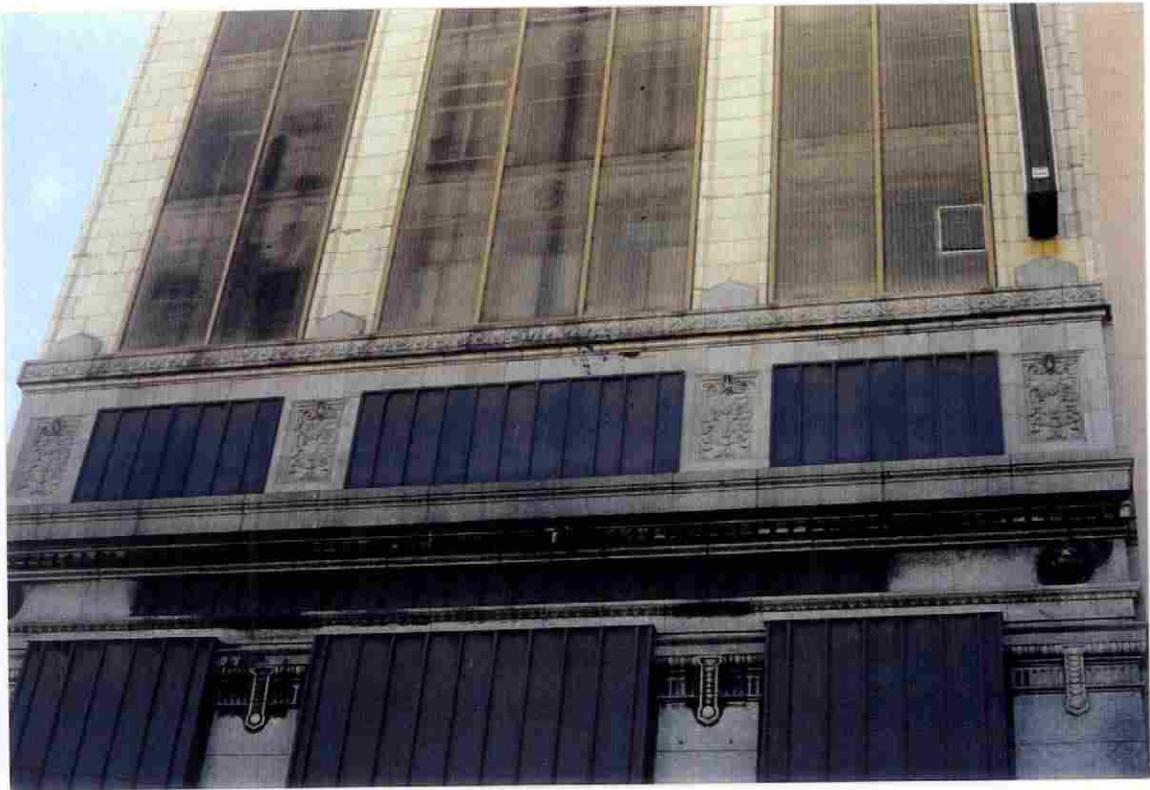
Security Building photo no.6
West facade, 2nd. and 3rd. level
non-original panels, pollution
effect on granite panels and
details. 9-10-99

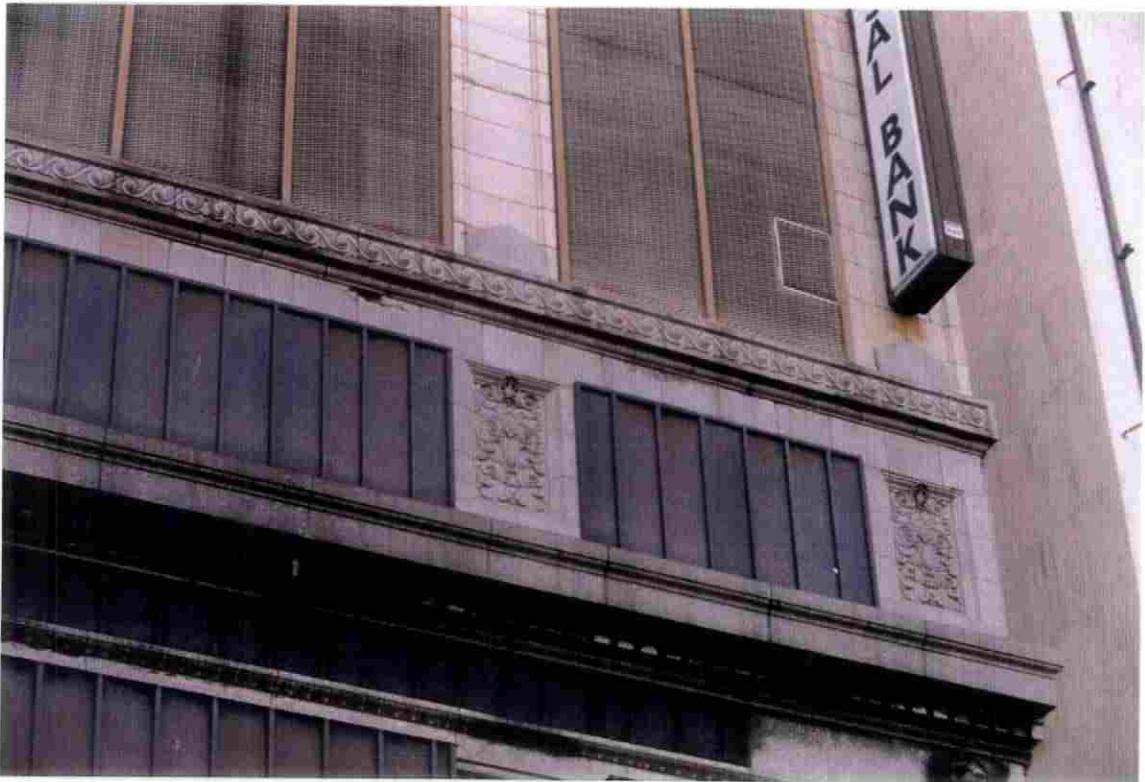
<table border="1"> <tr> <td>Number 5</td> <td>Architectural feature <u>West Facade</u></td> </tr> <tr> <td></td> <td>Approximate Date of feature <u>1926</u></td> </tr> </table>	Number 5	Architectural feature <u>West Facade</u>		Approximate Date of feature <u>1926</u>	<p>Describe existing feature and its condition:</p> <p>Granite and Terra-cotta panels spalling.</p> <p>Photo no. <u>7</u> Drawing no <u>HP-5</u></p>	<p>Describe work and impact on existing feature:</p> <p>Spalling will be repaired by removing all loose or friable material. All blistered areas will be coated and sealed. Panels which have lost most of its material and structural integrity will be replaced with complete units.</p>
Number 5	Architectural feature <u>West Facade</u>					
	Approximate Date of feature <u>1926</u>					
<table border="1"> <tr> <td>Number 6</td> <td>Architectural feature <u>West Facade</u></td> </tr> <tr> <td></td> <td>Approximate Date of feature <u>1926</u></td> </tr> </table>	Number 6	Architectural feature <u>West Facade</u>		Approximate Date of feature <u>1926</u>	<p>Describe existing feature and its condition:</p> <p>Holes and surfaces cracking in granite and terra-cotta panels created by signs and non-original awnings and metal screens.</p> <p>Photo no. <u>5-6-7</u> Drawing no <u>HP-5</u></p>	<p>Describe work and impact on existing feature:</p> <p>Existing holes and surface cracking will be permanently sealed with a sealer that will expand with the normal dynamics of the surrounding material. Restoration Mortar for Terra-cotta panels to be: Jahn M-100 Grouting if required to be: Jahn M-40 Or M-50 by Cathedral Stone Products, or approved equal.</p>

Security Building photo no.7
West facade, granite and
terra-cotta spalling.

- 2) Spot repairs to and limited replacement of damaged granite and terra cotta panels must match the appearance of the surrounding historic masonry. Product information, samples and mockups should be reviewed and approved by the State Historic Preservation Office before proceeding with this work. Good quality overall and close-up color photographs of the masonry before and after repairs/replacement must be submitted with the Request for Certification of Completed Work.

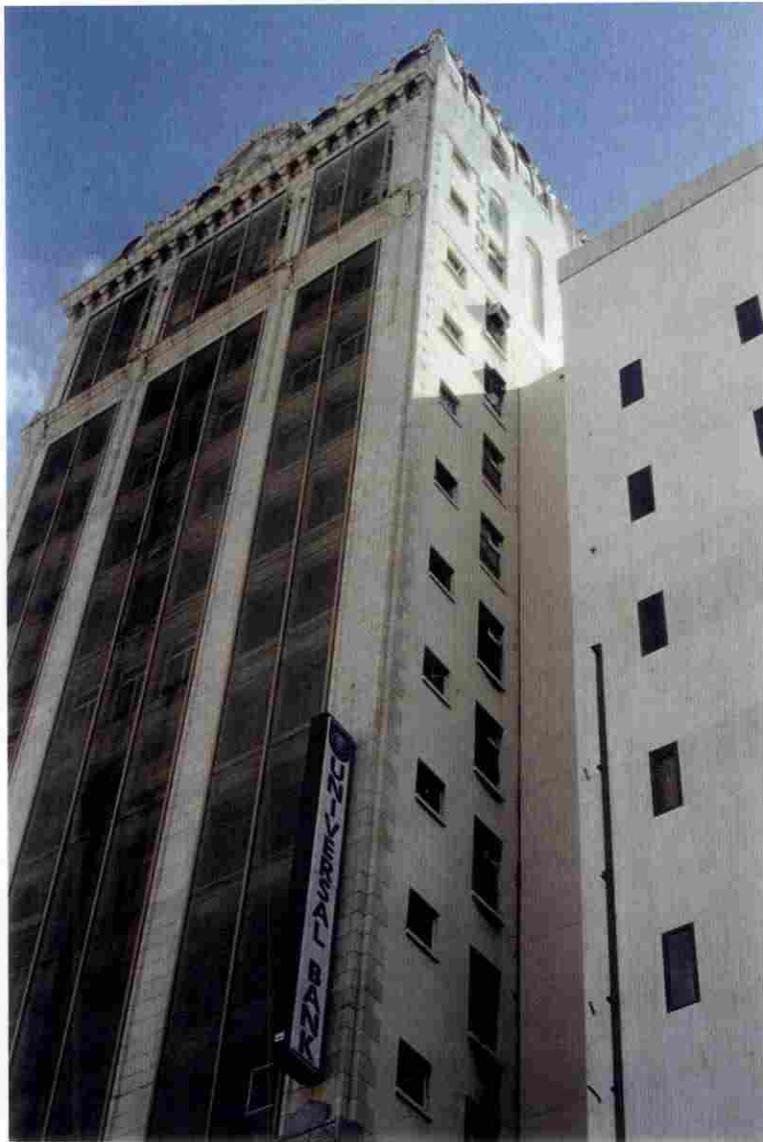
Security Building photo no.8
West facade, non-original metal
screen and sign.

Existing non-historic sign and graffiti to be removed.
Paint removal to be done with: Sureklean
859 Stripper
by Prosoco, Inc.

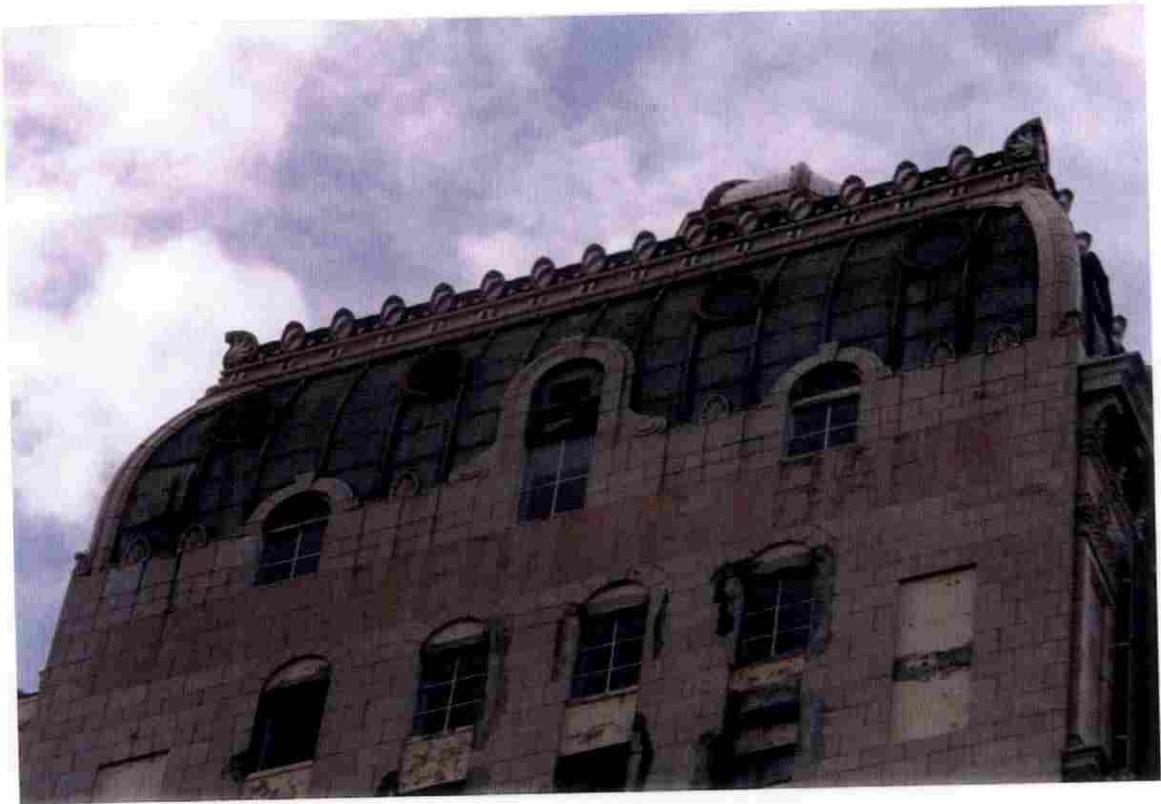
Security Building photo no.12

<table border="1" style="width: 100%; border-collapse: collapse;"> <tr> <td style="width: 20%; text-align: center;">Number 9</td> <td>Architectural feature <u>Windows</u></td> </tr> <tr> <td></td> <td>Approximate Date of feature <u>1926</u></td> </tr> </table> <p>Describe existing feature and its condition:</p> <p>Existing windows are historic and in fair condition.</p> <p>Photo no. <u>12-13-14-15</u> Drawing no <u>HP-5,HP-6,HP-7</u> <u>HP-8</u></p>	Number 9	Architectural feature <u>Windows</u>		Approximate Date of feature <u>1926</u>	<p>Describe work and impact on existing feature:</p> <p>All windows to remain. Windows will be restored, loose paint and rust will be removed, frames will be primed and painted. Caulk and seal around openings. Broken glass replaced with clear glass. No tinted glass allowed.</p>
Number 9	Architectural feature <u>Windows</u>				
	Approximate Date of feature <u>1926</u>

Original metal windows

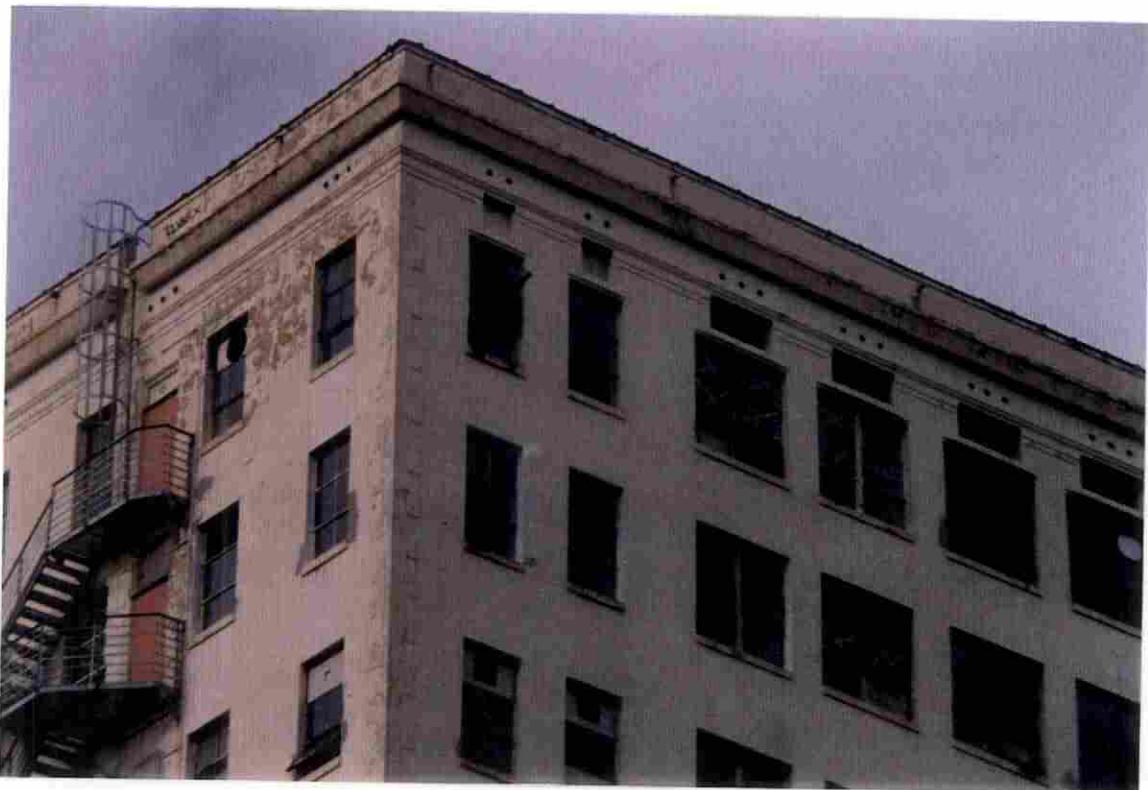
Security Building photo no. 13

Original metal windows

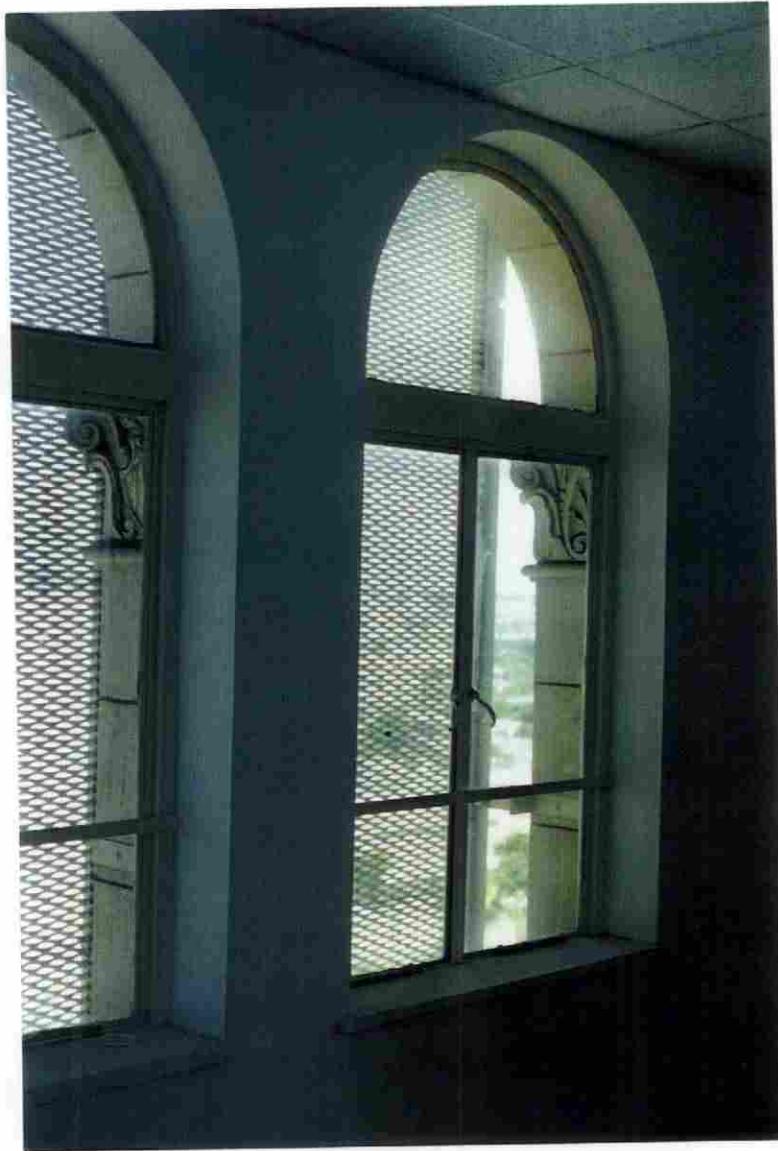
Security Building photo no.14

Original metal windows

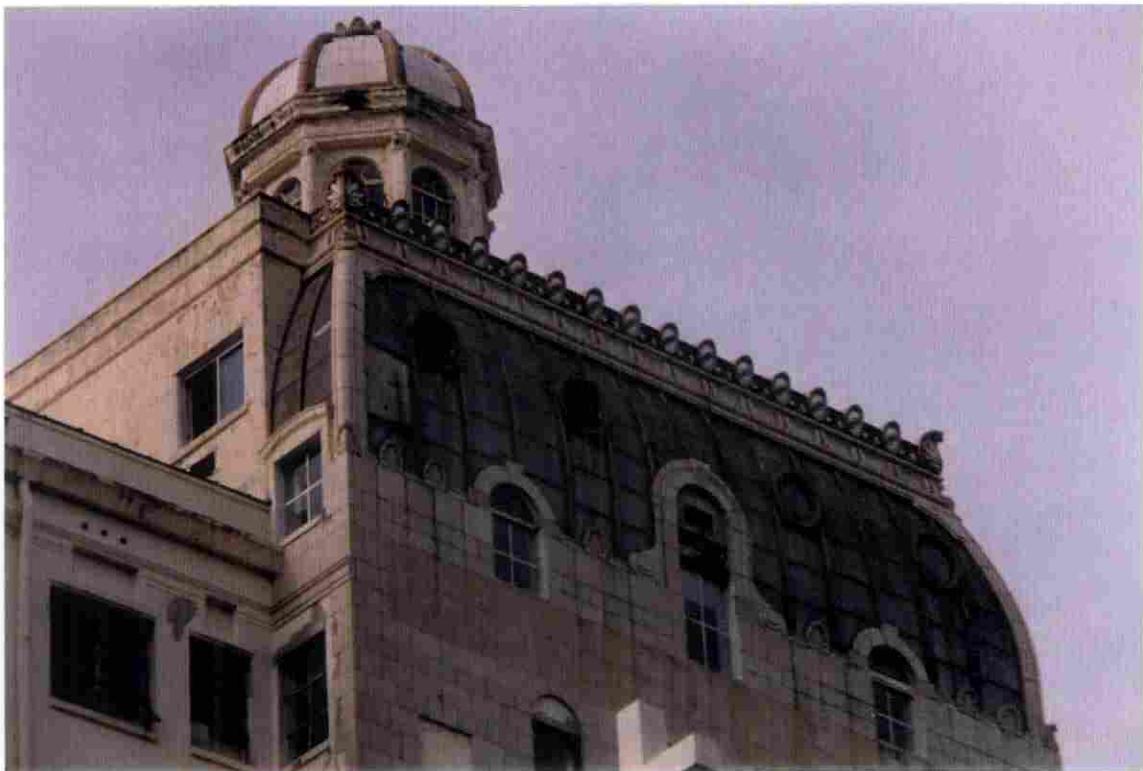
Security Building photo no.15

<table border="1" style="width: 100%; border-collapse: collapse;"> <tr> <td style="width: 20%; text-align: center;">Number 10</td> <td>Architectural feature <u>Copper faced mansard roof</u></td> </tr> <tr> <td></td> <td>Approximate Date of feature <u>1926</u></td> </tr> </table> <p>Describe existing feature and its condition:</p> <p>Copper roof in good condition. One copper panel missing at east side of north elevation.</p> <p>Photo no. <u>12-15</u> Drawing no <u>HP-5,HP-6,HP-7</u></p>	Number 10	Architectural feature <u>Copper faced mansard roof</u>		Approximate Date of feature <u>1926</u>	<p>Describe work and impact on existing feature:</p> <p>Patina finish of copper roof to remain. Panel missing to be replaced with new. Finish to match existing.</p>
Number 10	Architectural feature <u>Copper faced mansard roof</u>				
	Approximate Date of feature <u>1926</u>				
<table border="1" style="width: 100%; border-collapse: collapse;"> <tr> <td style="width: 20%; text-align: center;">Number 11</td> <td>Architectural feature <u>Ground Level-West Facade Storefronts</u></td> </tr> <tr> <td></td> <td>Approximate Date of feature <u>Non-original</u></td> </tr> </table> <p>Describe existing feature and its condition:</p> <p>Contemporary metal-glass storefronts to be removed.</p> <p>Photo no. <u>16-17</u> Drawing no <u>HP-5,HP-10, HP-16,HP-25</u></p>	Number 11	Architectural feature <u>Ground Level-West Facade Storefronts</u>		Approximate Date of feature <u>Non-original</u>	<p>Describe work and impact on existing feature:</p> <p>Non-historic storefronts to be removed. Historic renderings and floor plan found of ground level area show the entry area as a curvilinear recessed loggia . Evaluation of original entry design will be done after selective demolition of non-historic alterations. If we are able to determine that indeed the entry area was built as shown on renderings and plans, new wall to match curved plan layout. Proposed elevation to implement some of the original architectural details used in the original design.</p>

Copper faced mansard roof

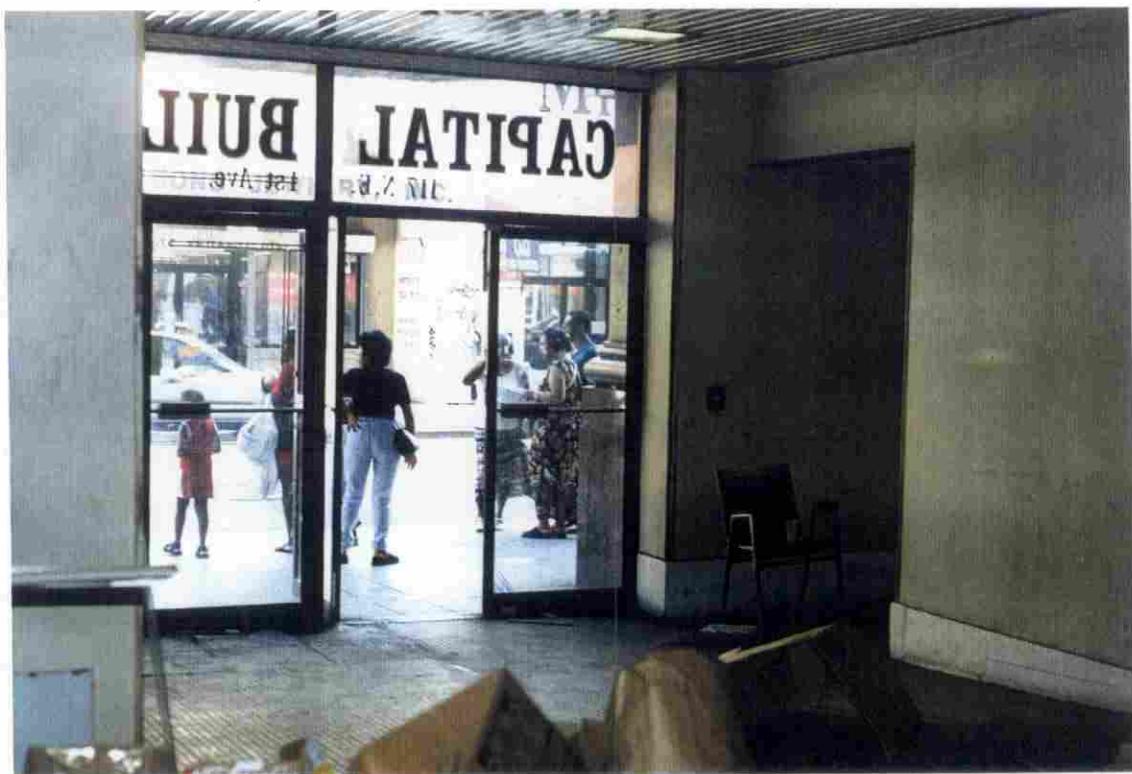
Security Building photo no.17
Entry Lobby, non-original storefronts.

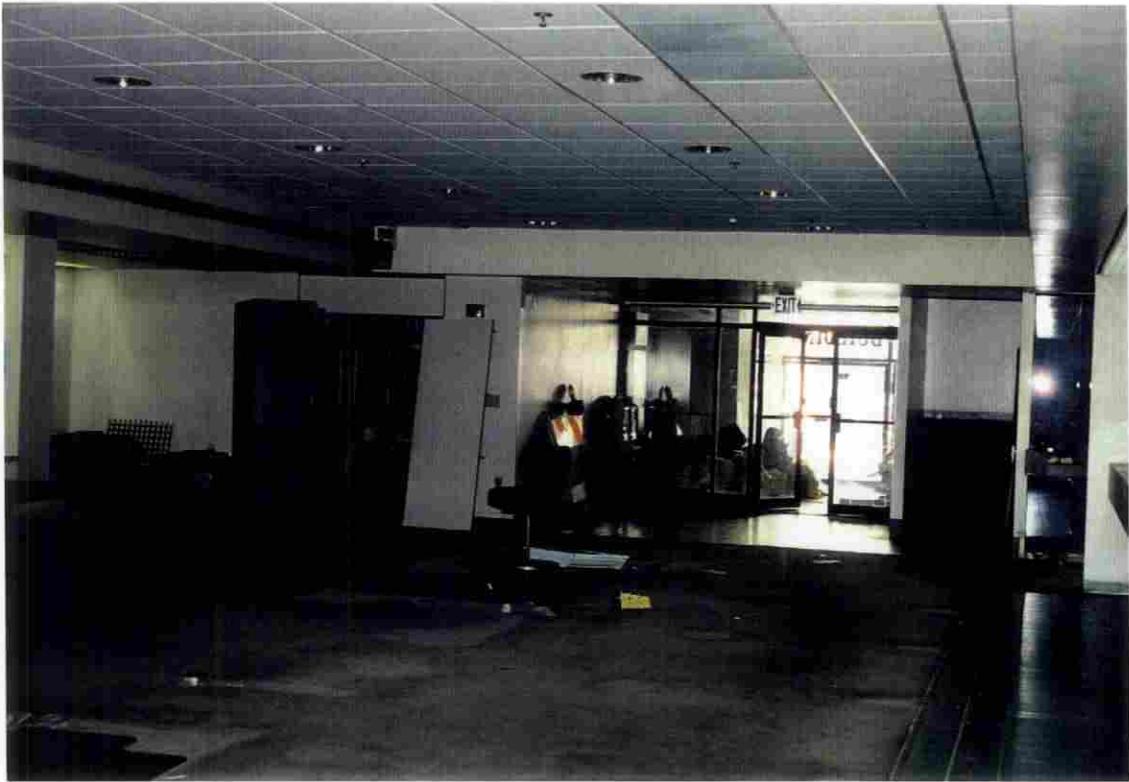
Security Building photo no.18
Ground level, west view
Commercial alterations.

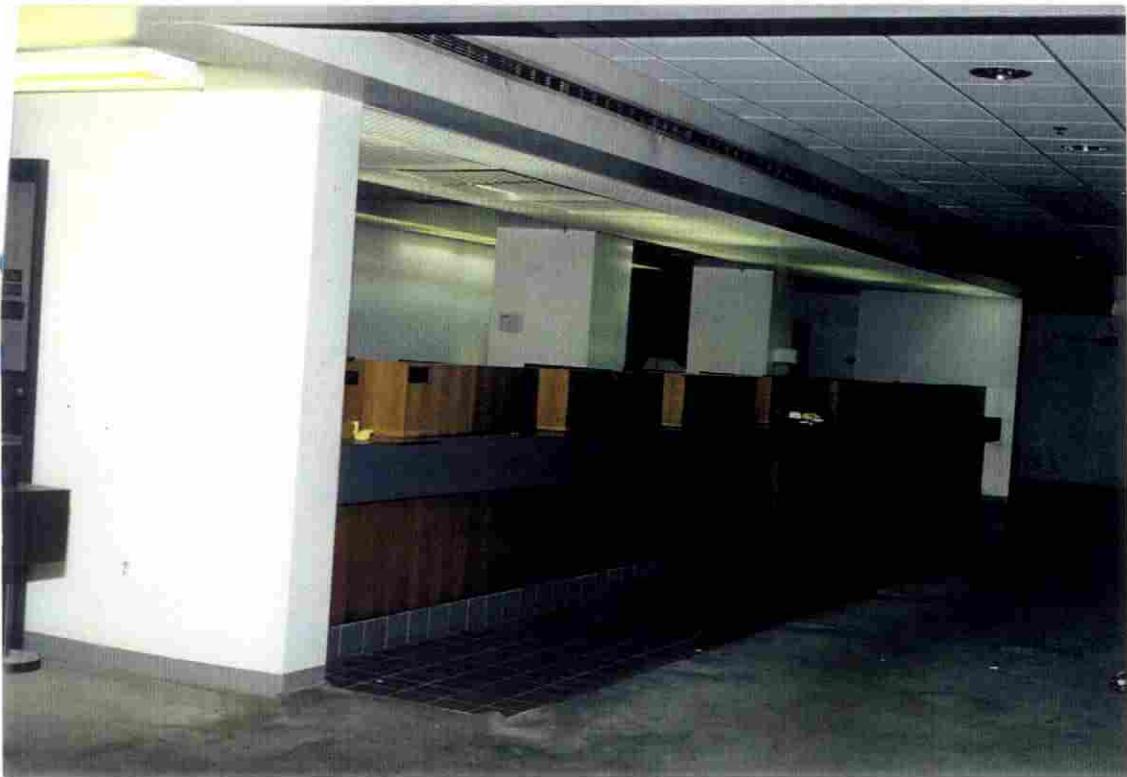
Security Building photo no.19
Ground level, north view
Commercial alterations.

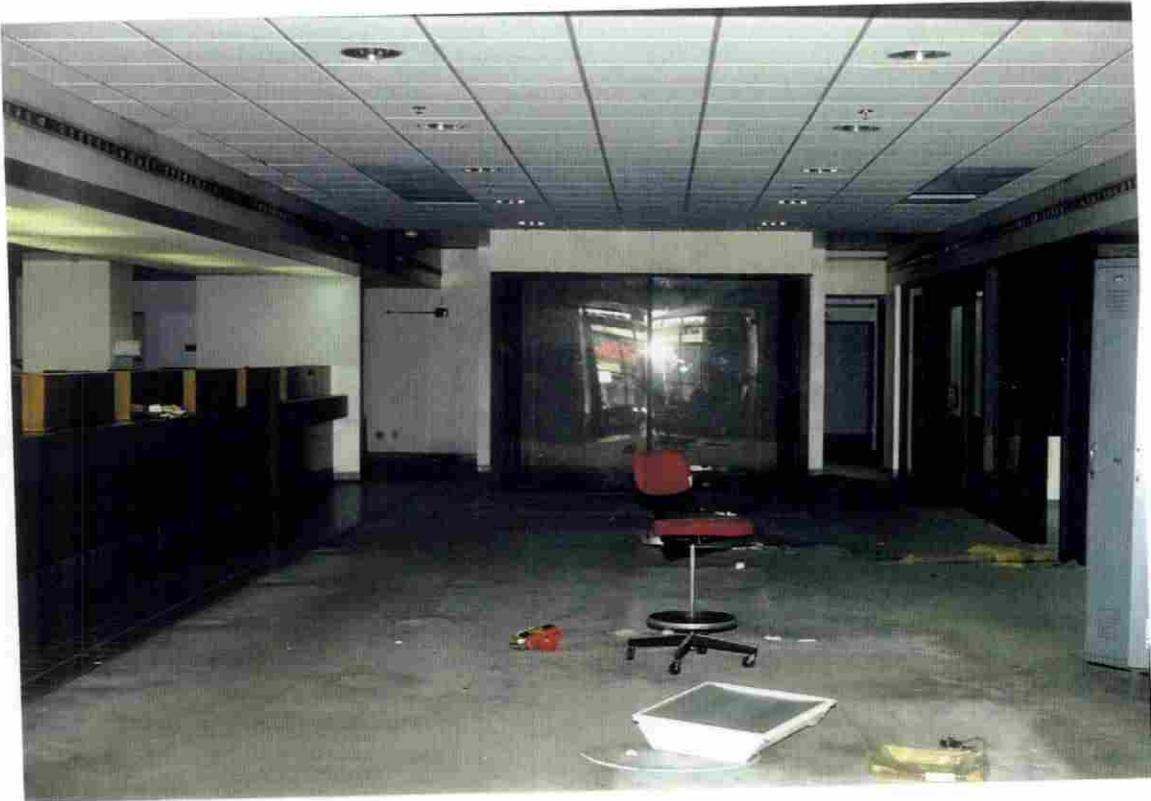
Security Building photo no.
Ground level, East view 20
Commercial alterations.

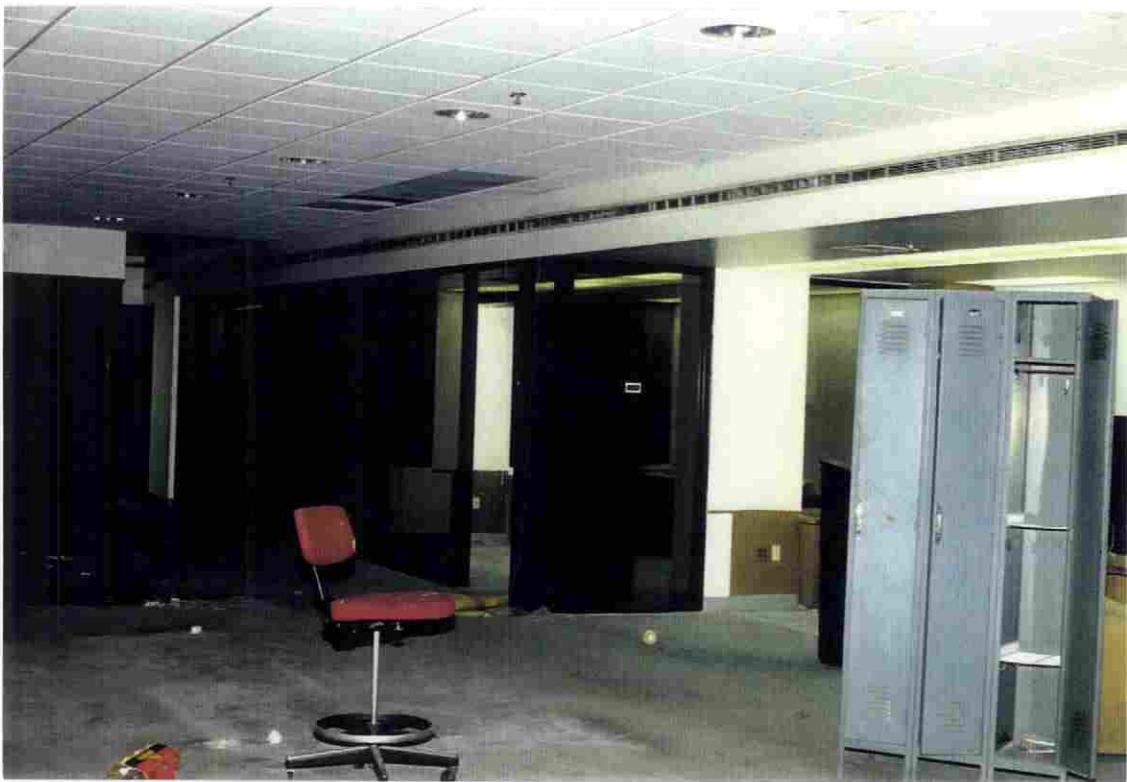
Security Building photo no.
Ground level, South view 21
Commercial alterations.

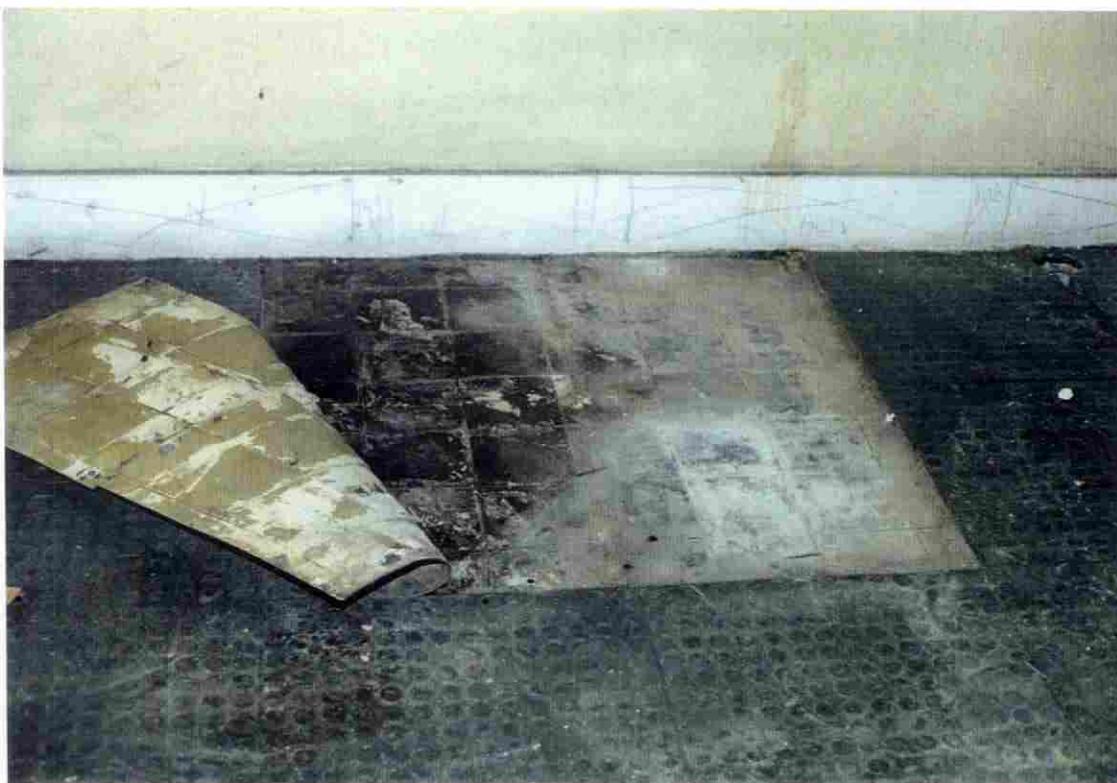
Security Building photo no. 22
Entry Lobby, non-original viny
floor over a 4"x4" paver.

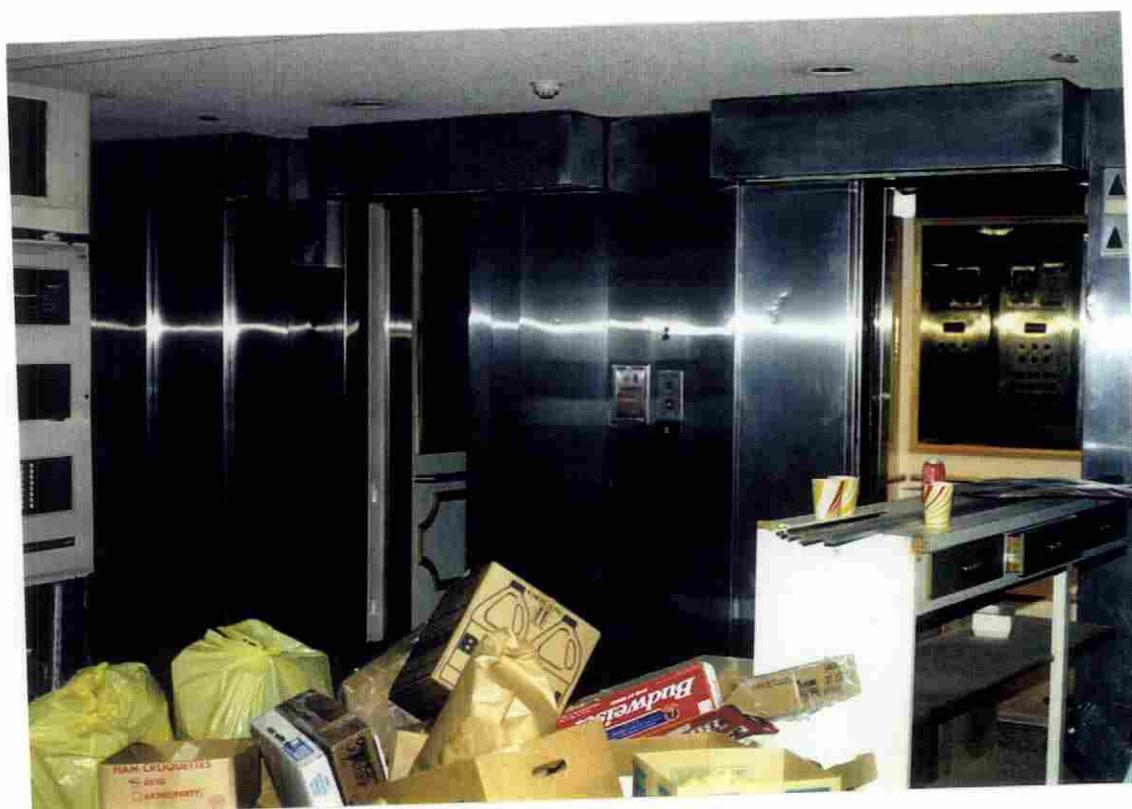
Security Building photo no. 23
Ground level, Elevator Lobby.
Non-original metal cladding

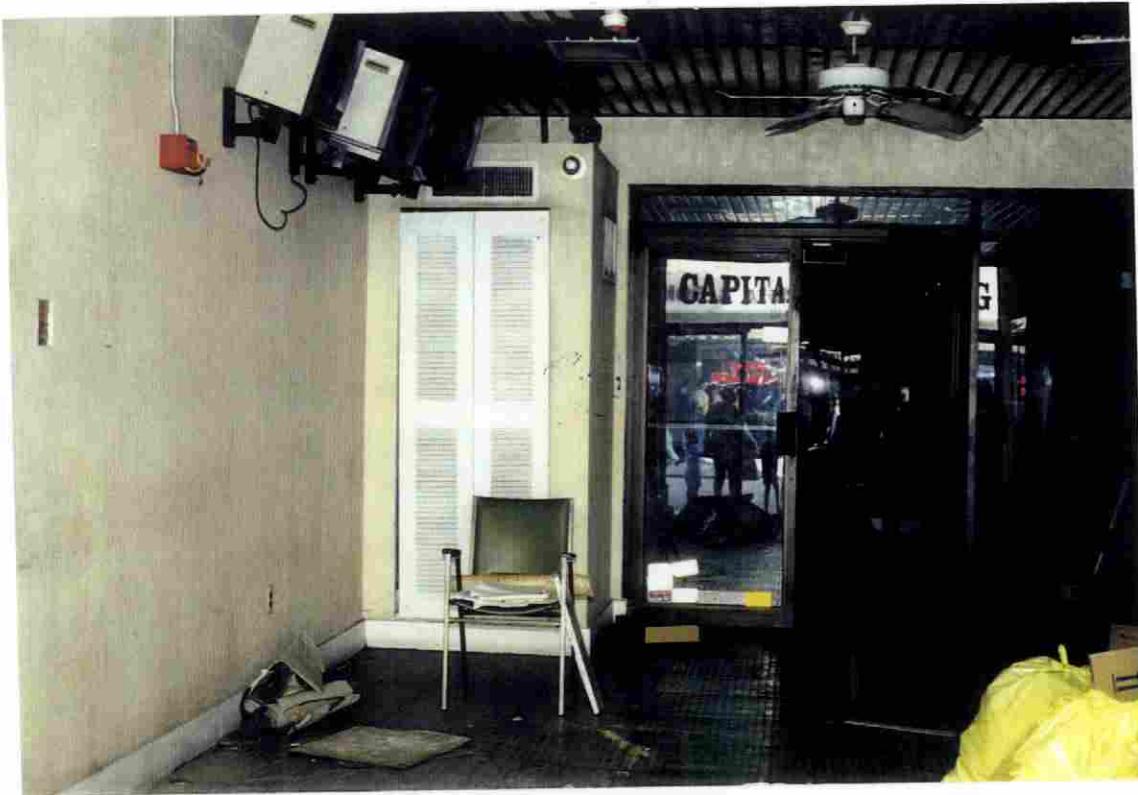
Security Building photo no. 24
Ground level, Elevator Lobby
Commercial alterations.
NE view.
9-10-99

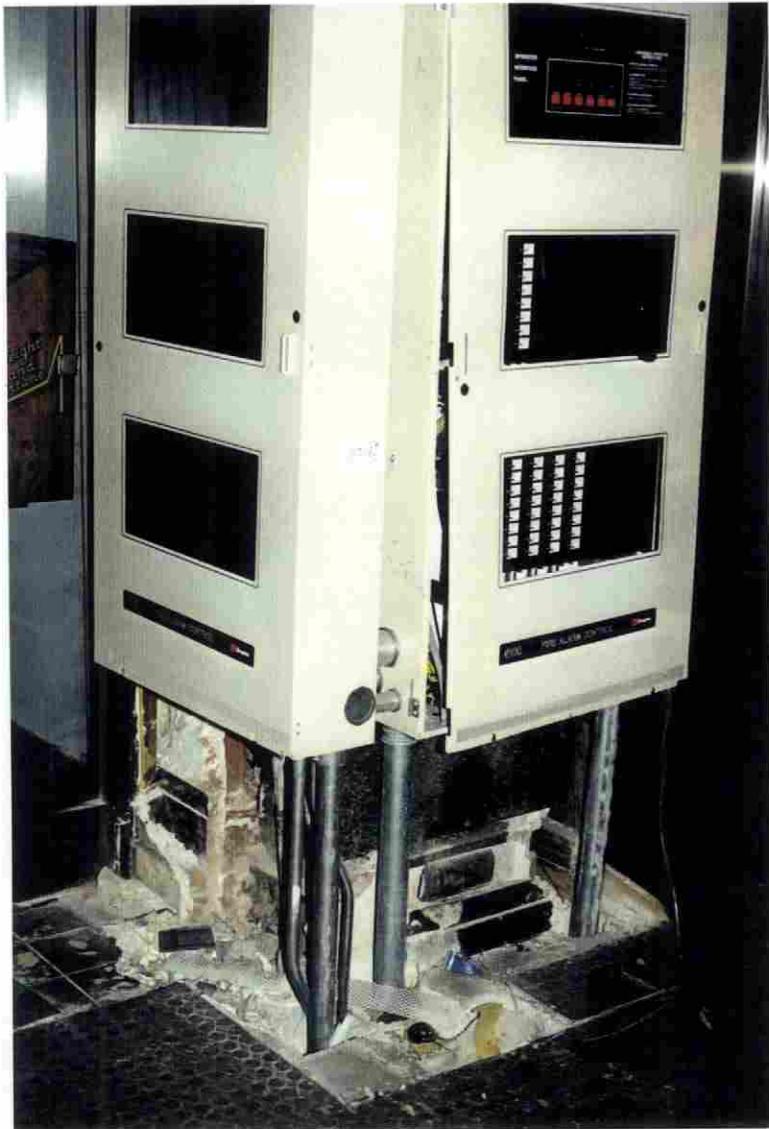
Security Building photo no. 26
Ground Level, Elevator Lobby
Commercial alterations.
Alarm Panel over granite colu:
9-10-99

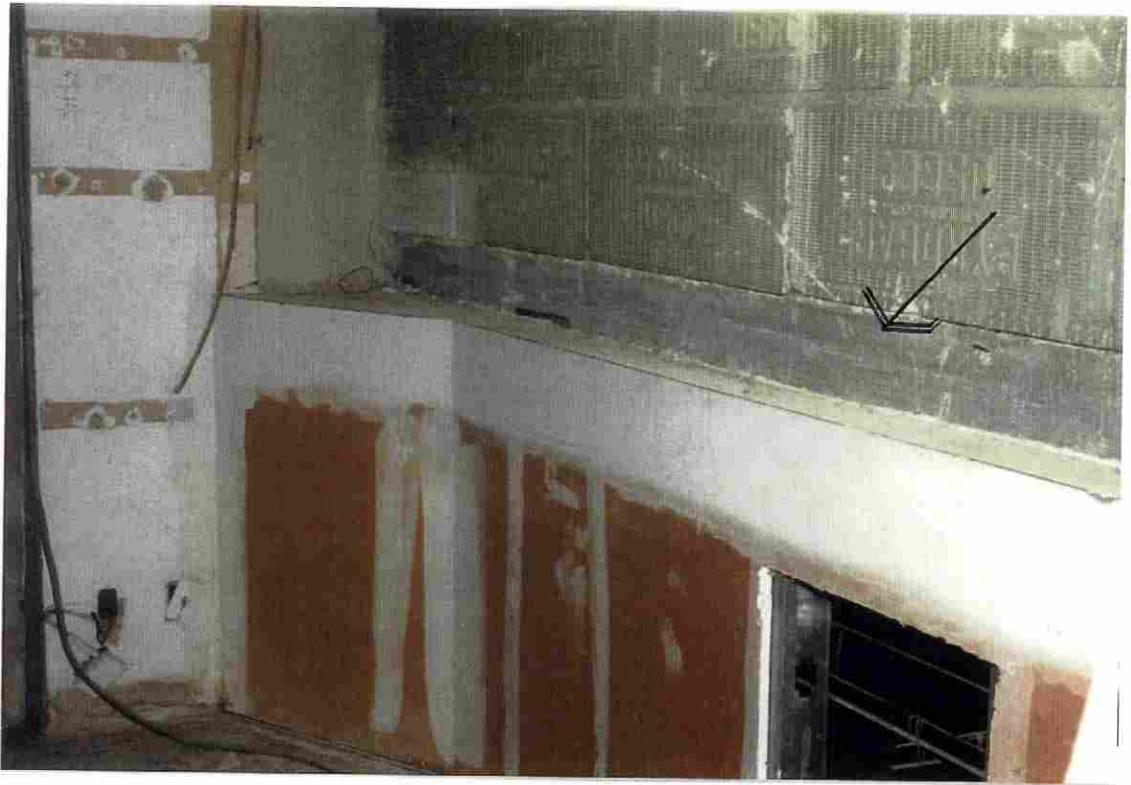
Security Building photo no.28
Mezzanine Level
Non-original concrete slab

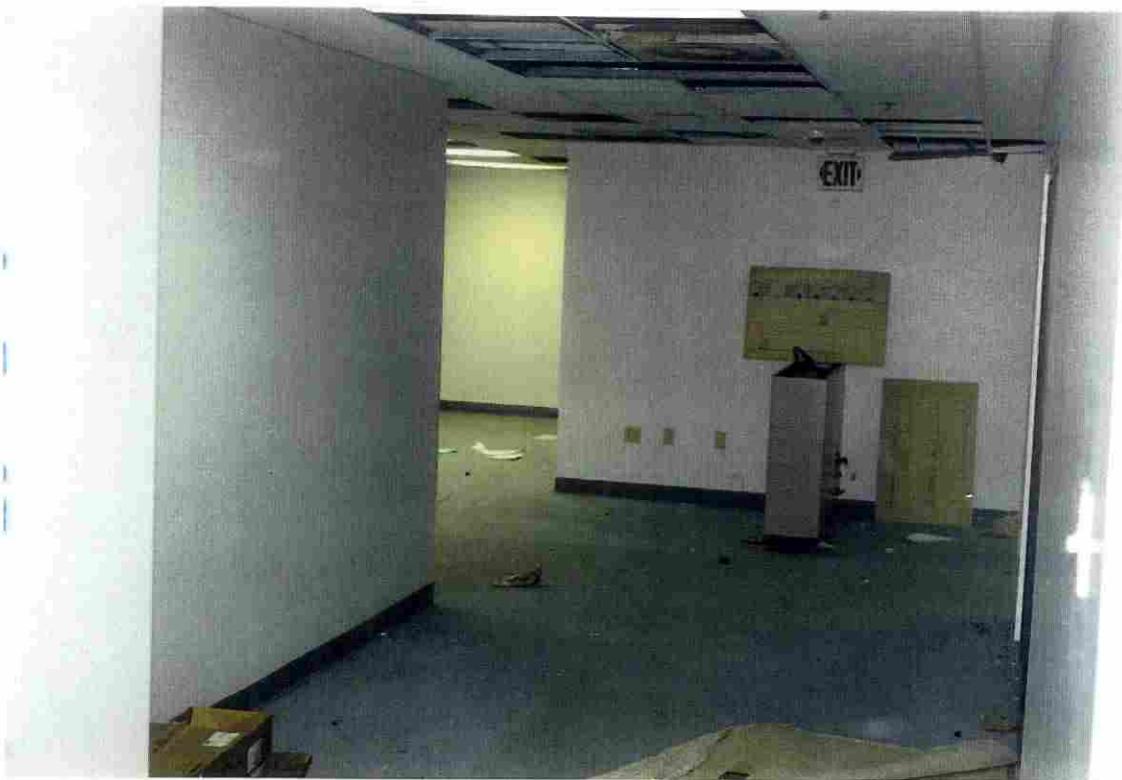
Security Building photo no.29
Mezzanine Level
Commercial alterations
New wallboard partitions
