National Register of Historic Places
Inventory—Nomination FormSee instructions in *How to Complete National Register Forms*
Type all entries—complete applicable sections**1. Name**

historic Security Building

street & number 117 N. E. 1st Avenue

city, town Miami

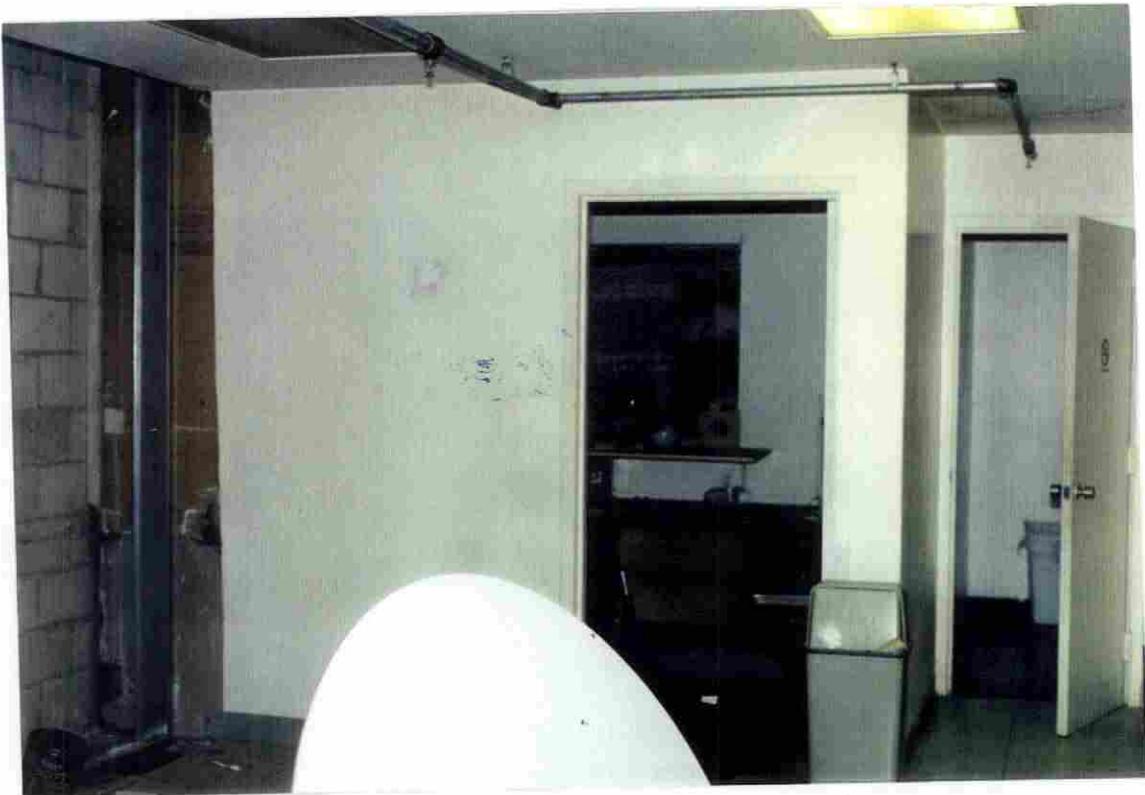
9-10-99
Security Building photo no.30
Mezzanine Level
Commercial alterations

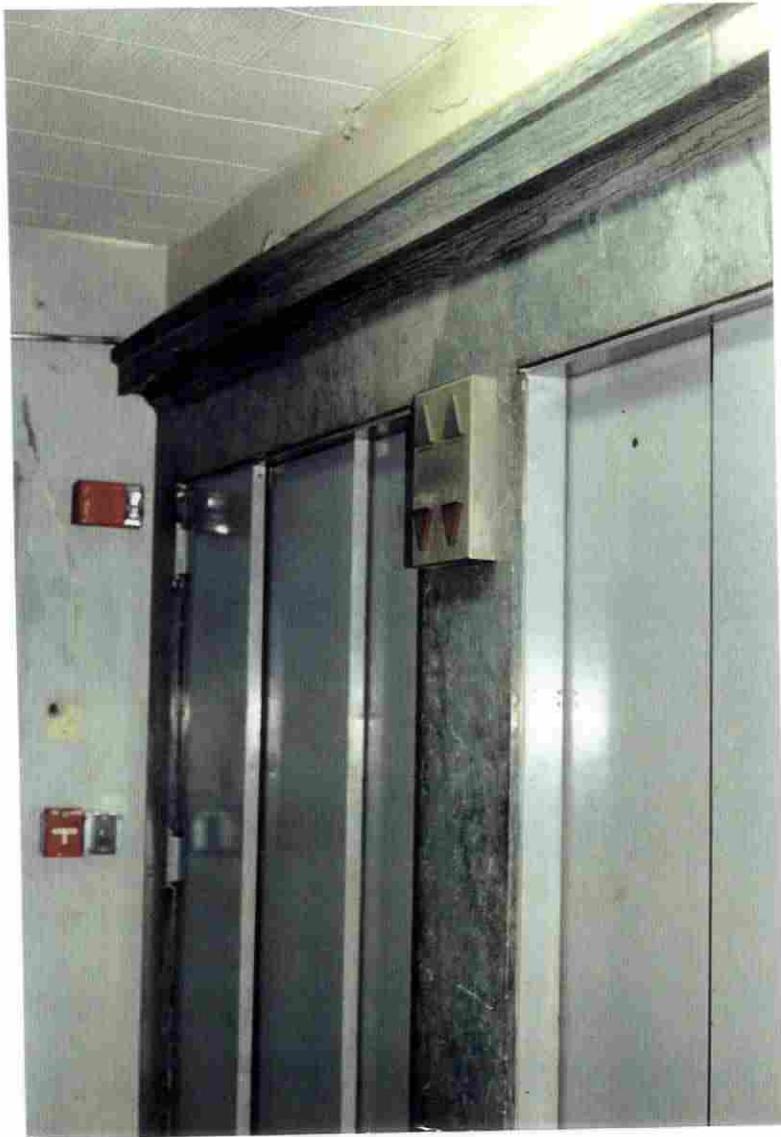
<p>Number 17</p>	<p>Architectural feature <u>Mezzanine Walls</u></p> <p>Approximate Date of feature <u>Non-original</u></p>	<p>Describe work and impact on existing feature:</p> <p>All existing gypsum wall board alterations to be removed. Extent of restoration of wall finishes and details to be determined after selective demolition.</p>
<p>Describe existing feature and its condition:</p> <p>Contemporary gypsum wall board partitions throughout.</p> <p>Photo no. <u>29-30</u> Drawing no <u>HP-11,HP-17</u></p>		
<p>Number 18</p>	<p>Architectural feature <u>Mezzanine Elevator Walls</u></p> <p>Approximate Date of feature <u>1926</u></p>	<p>Describe work and impact on existing feature:</p> <p>Existing Marble Wainscot to remain. To be patched, filled and restored as required.</p>
<p>Describe existing feature and its condition:</p> <p>Existing Marble wainscot in fair condition.</p> <p>Photo no. <u>31-32-33</u> Drawing no <u>HP-11,HP-17</u></p>

Security Building photo no.32
Mezzanine Level, Elevator walls
Historic marble wainscot
East view
9-10-99

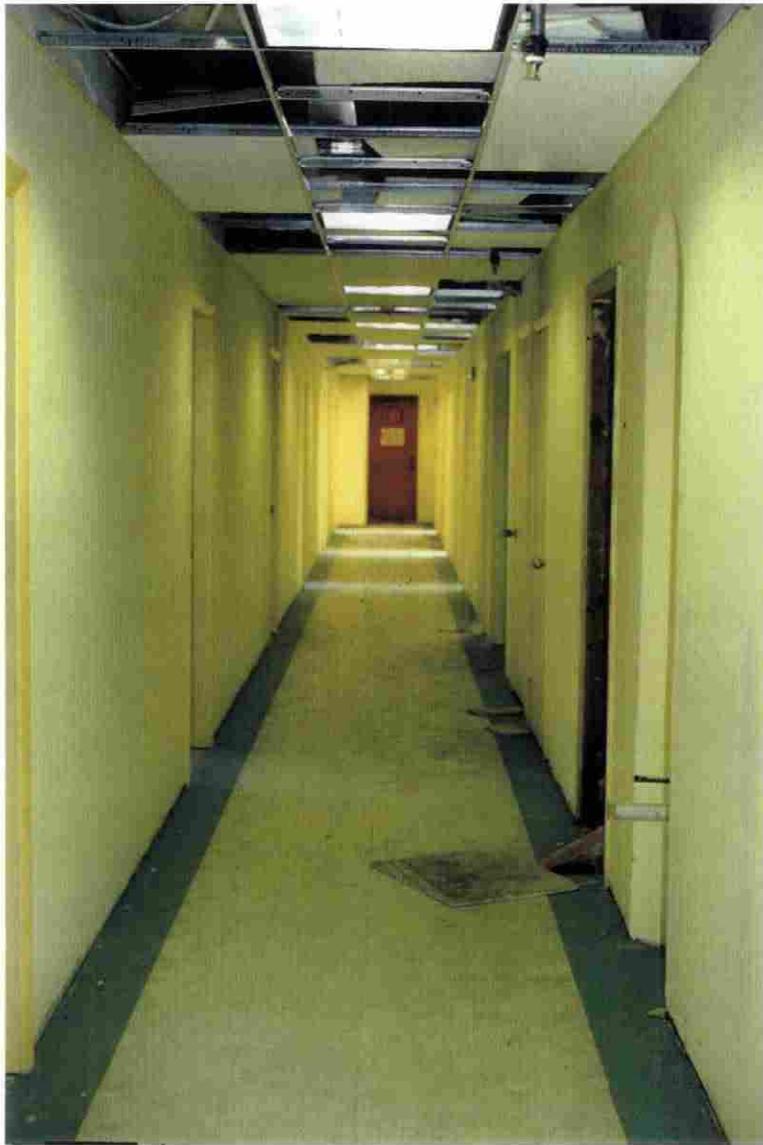
Photo no. 34 submitted with Application shows altered corridor at 7th floor looking east. All corridors were similarly altered as shown on this photo. These corridors have been removed. (please see attached photos of existing conditions). Photo no.35 submitted with Application shows original wood wainscot, door frames, blocked transoms and marble base at 5th floor looking east. Proposed corridors will have door entrances to follow new plan and walls will have the same treatment as shown on this photo.

Security Building photo no.34
Typical Floor
Commercial alterations

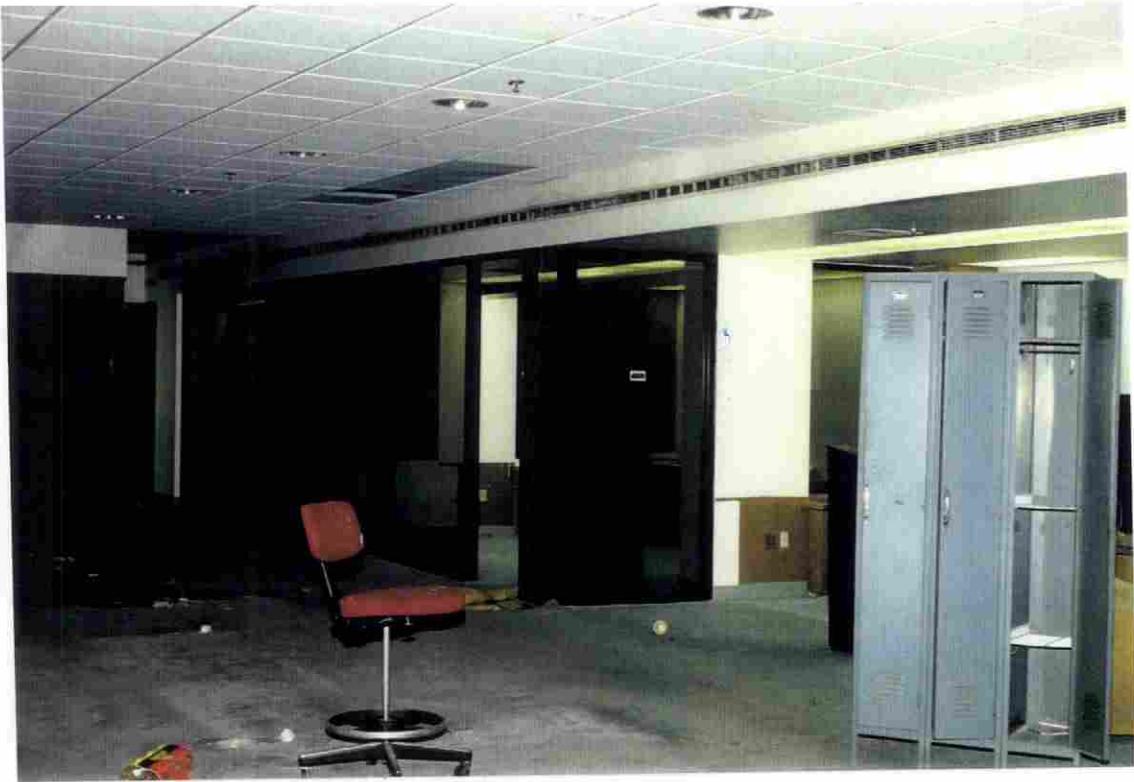
<p>Describe existing feature and its condition:</p> <p>Metal Ceiling at Entry Lobby, Acoustical Ceilings throughout Ground and Mezzanine Levels. Original ceilings have been removed and moldings have been cut to allow for introduction of Mechanical systems, electrical conduits and sprinkler lines.</p> <p>Photo no. <u>17-18-19-20-21-36-37</u> Drawing no. <u>HP-10A,HP-11A</u> <u>38-39-40-41</u></p>

Security Building photo no.36
Ground Level
Commercial alterations, suspended
ceilings, lights, hvac, sprinklers
9-10-99

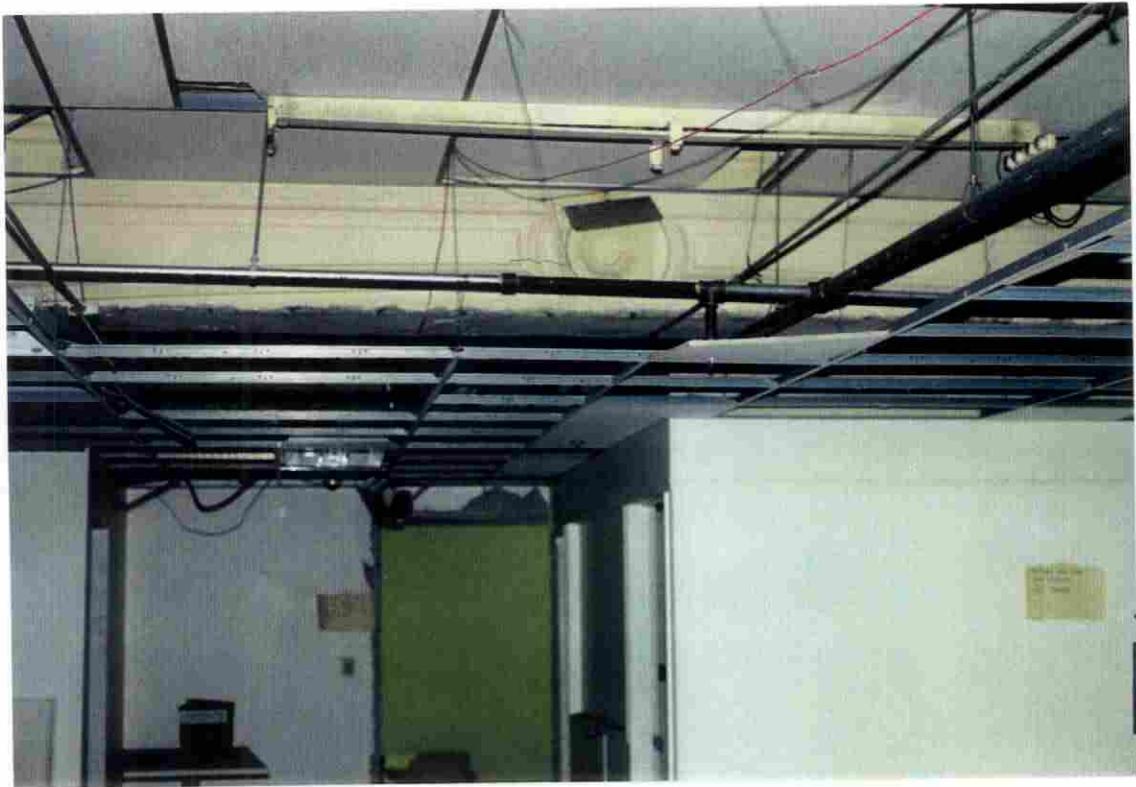
Security Building photo no.37
Mezzanine Level, Suspended ceilg.
over historic plaster mouldings.

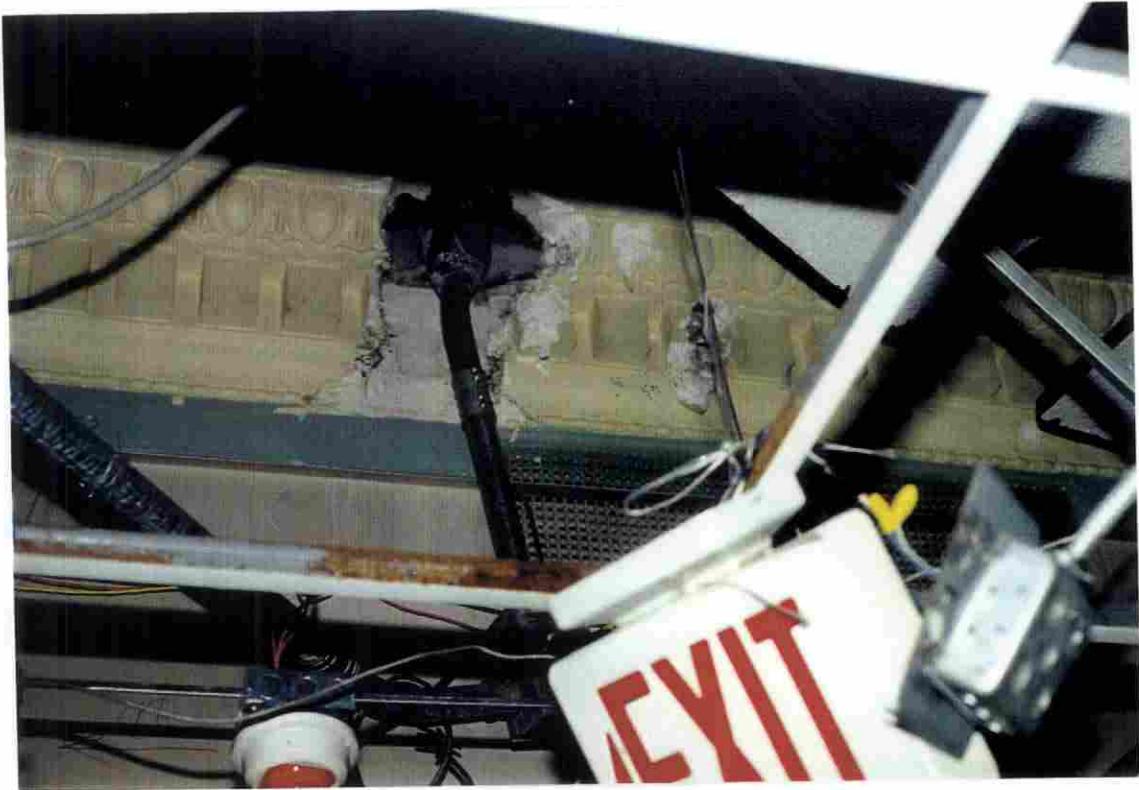
Security Building photo no.38
Mezzanine Level Ceiling
Commercial alterations damaged
mouldings throughout.
9-10-99

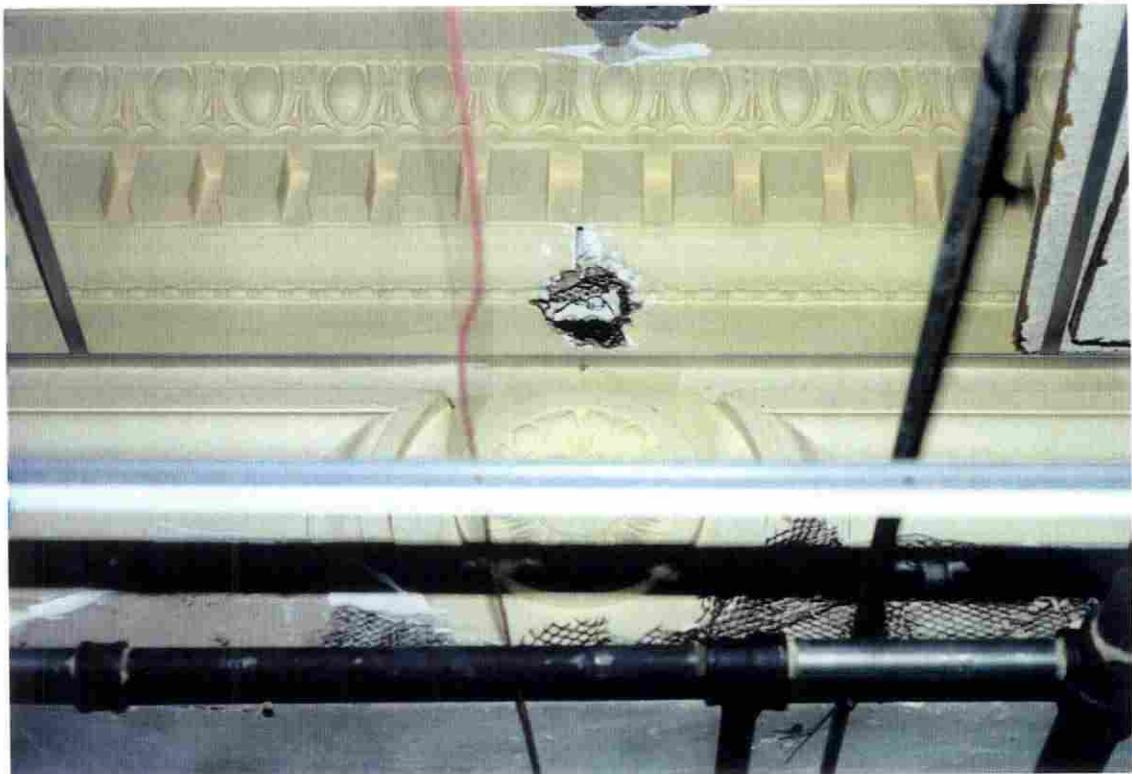
Security Building photo no.39
Mezzanine Level Ceiling
Commercial alterations damaged
plaster mouldings throughout.
9-10-99

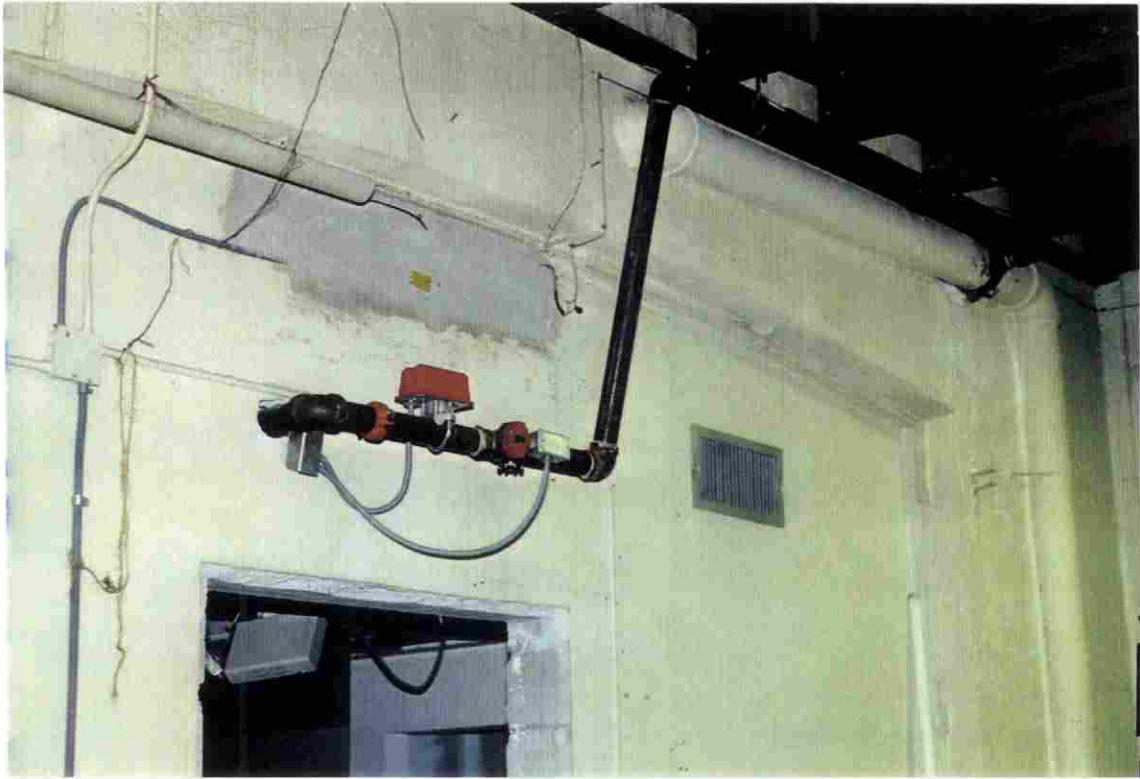
Security Building photo no.40
Mezzanine Level
Commercial Alterations
9-10-99

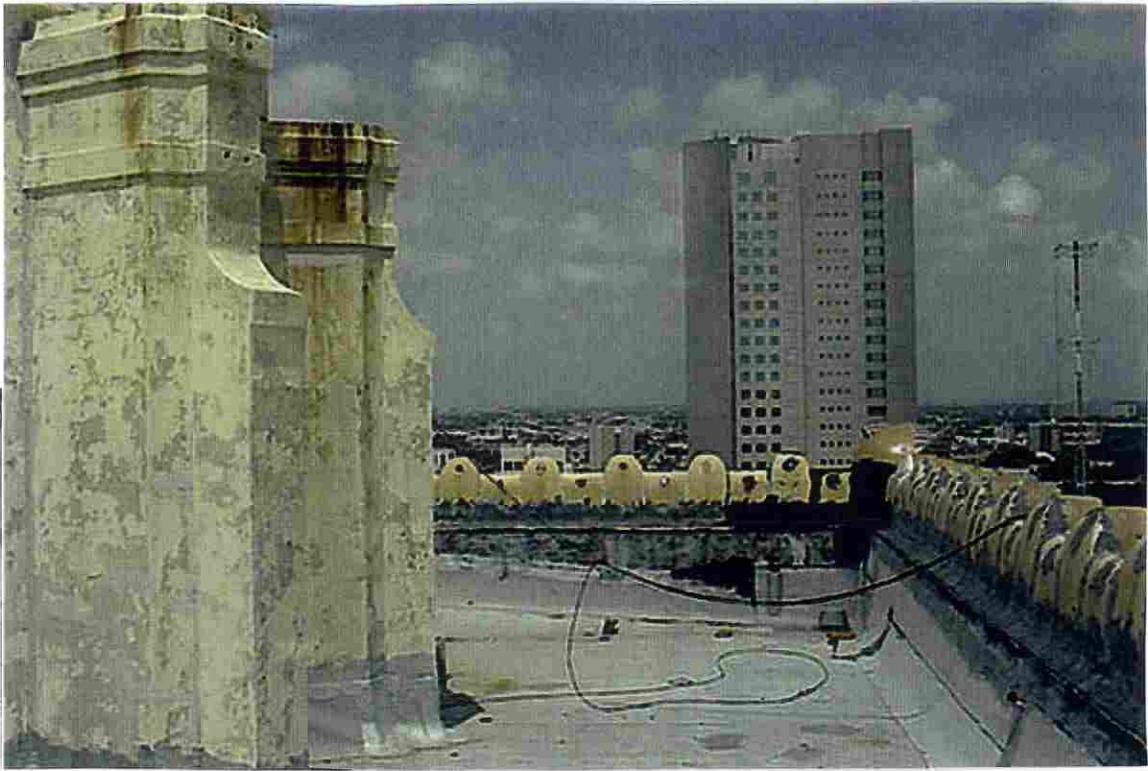
Security Building photo no. 44

Existing Built-up roof in fair condition.

Built-up Roof
North view

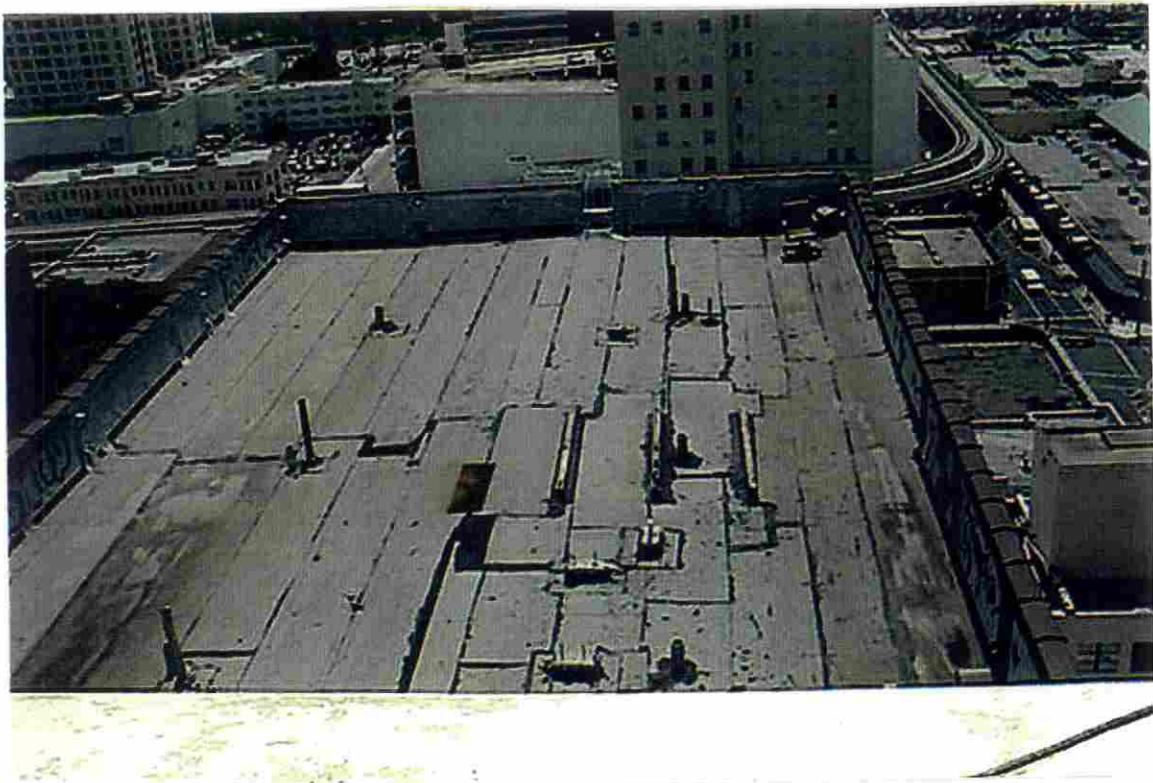
Security Building photo no.45

Built up Roof
East view
