National Register of Historic Places
Inventory—Nomination FormSee instructions in *How to Complete National Register Forms*
Type all entries—complete applicable sections**1. Name**

historic Security Building

street & number 117 N. E. 1st Avenue

city, town Miami

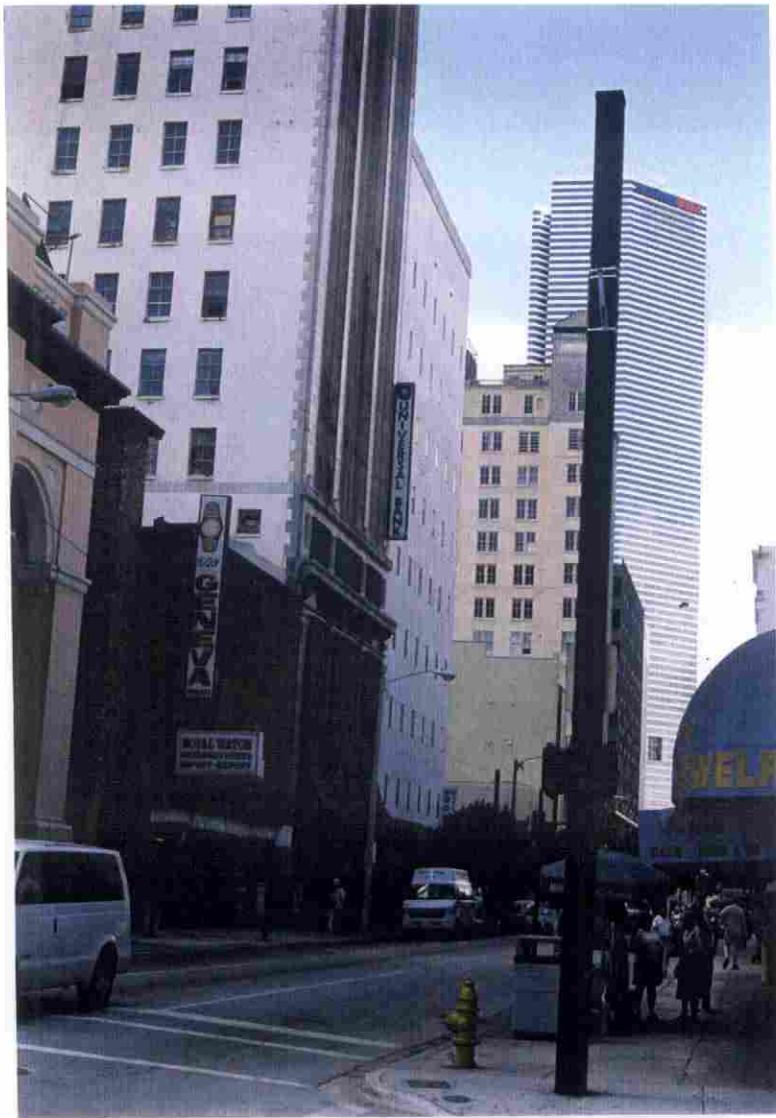
Security Building Photo no.1

NE 1st. Ave. South View
West Elevation

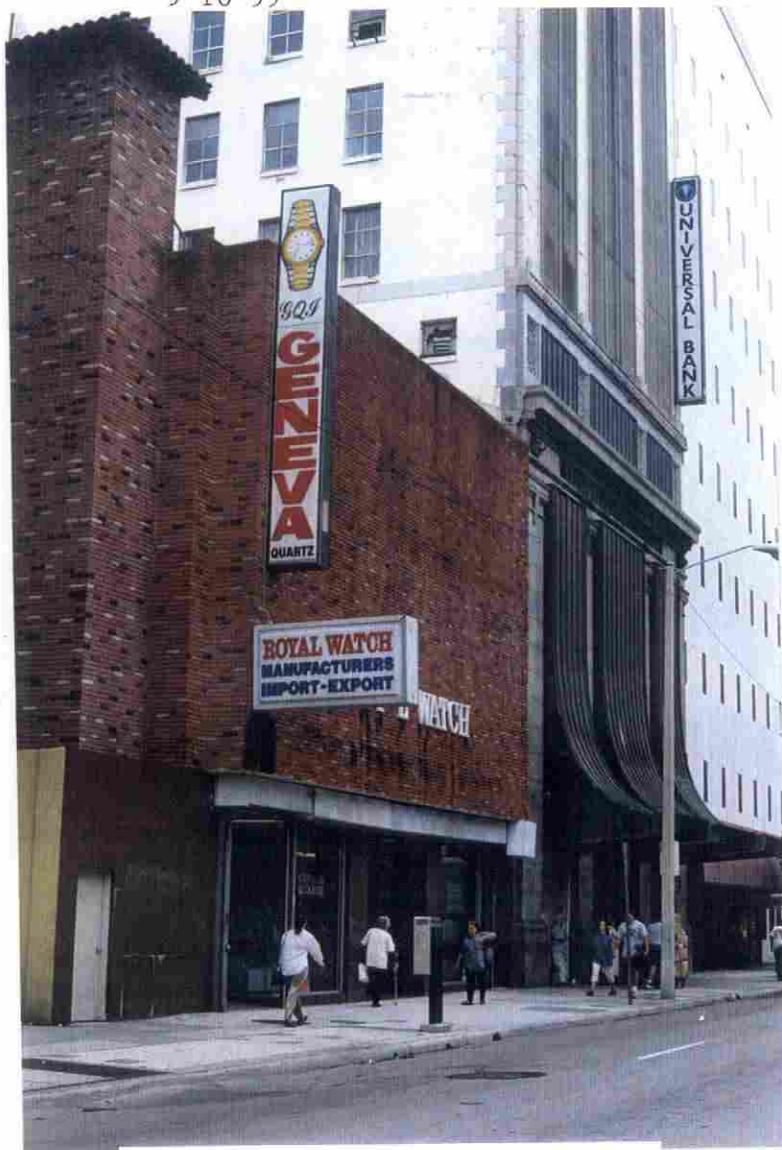
Security Building photo no.2

NE 1st. Ave. South View
Three story bldg. at north side
9-10-99

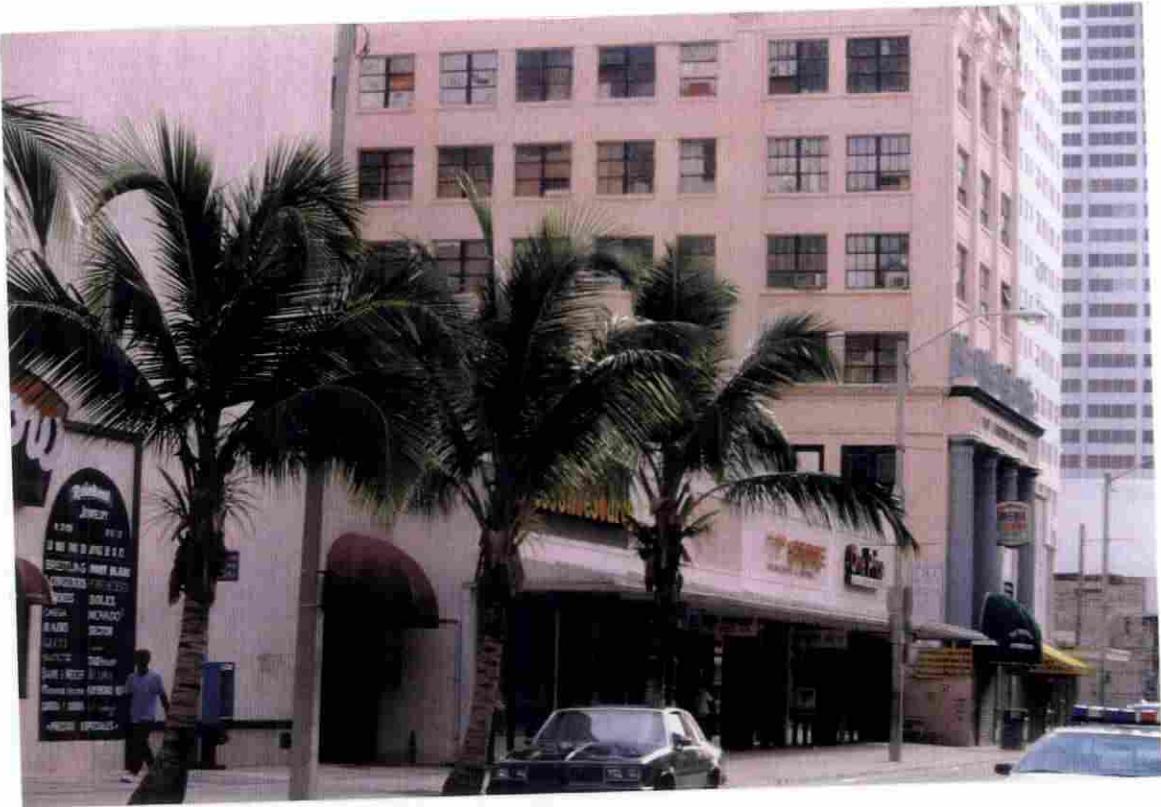
Security Building photo no.3

Existing structures at East side

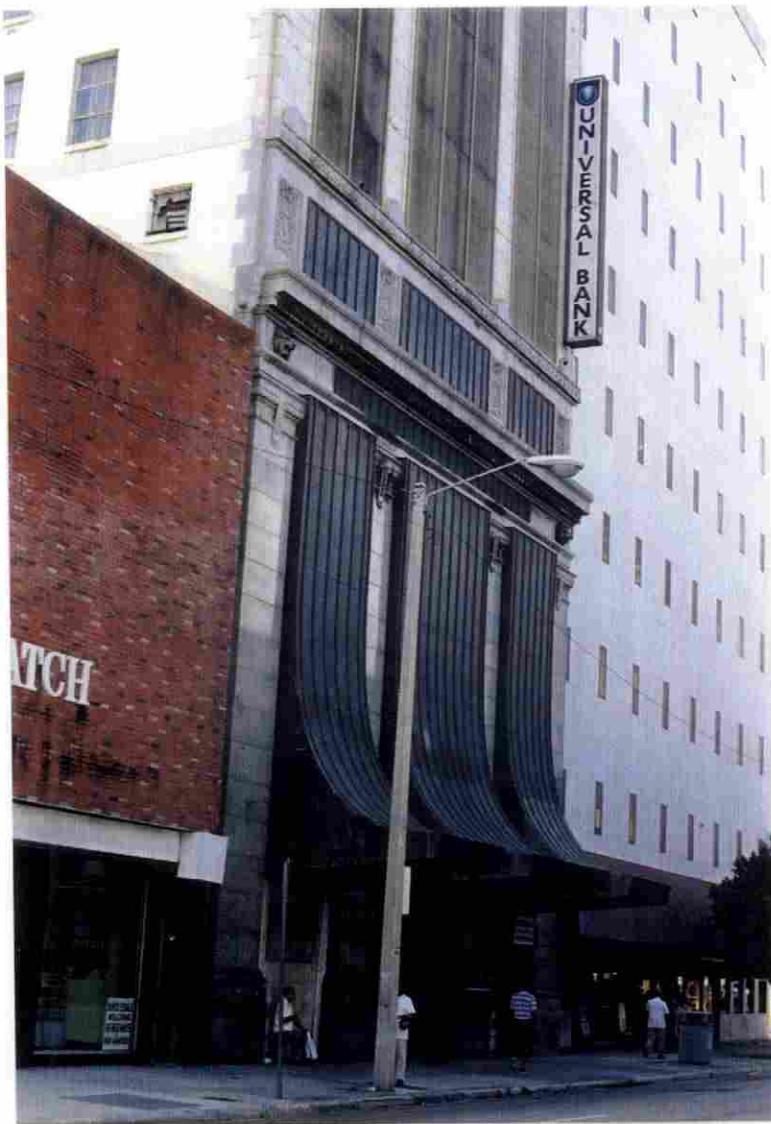
Security Building photo no.5

West facade - lower floors
Granite panels, non-original
awnings. 9-10-99

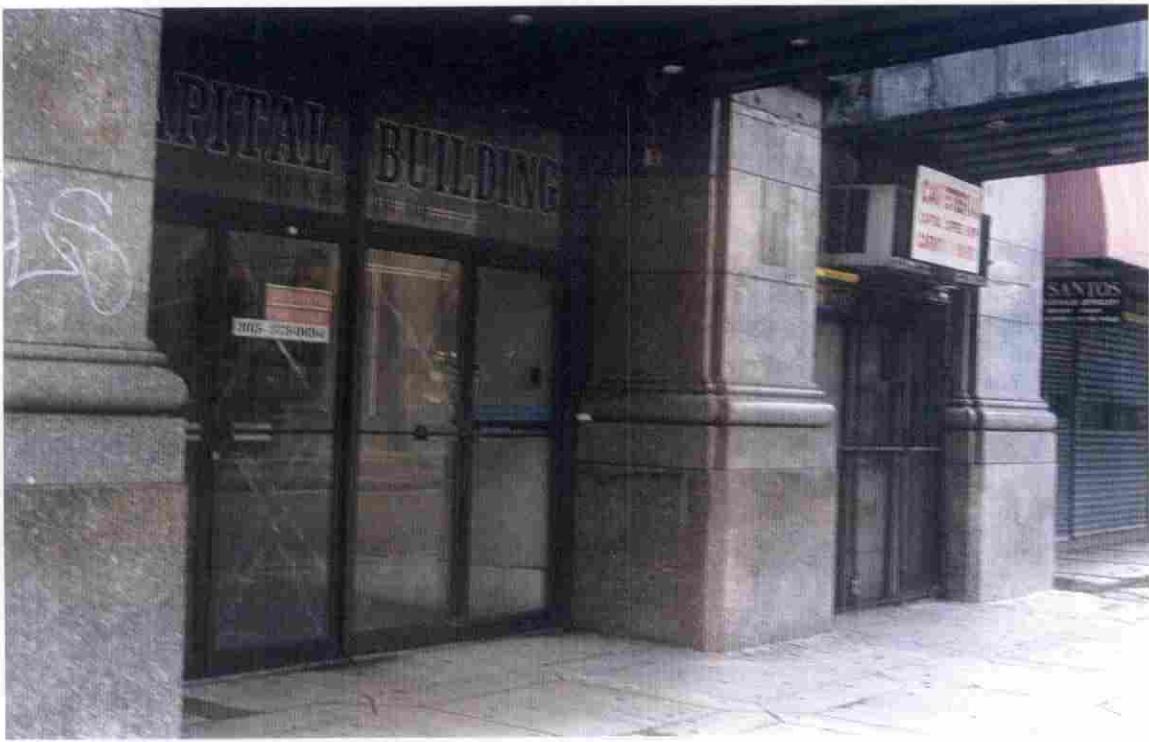
Security Building photo no.16

West facade, non-original storefronts

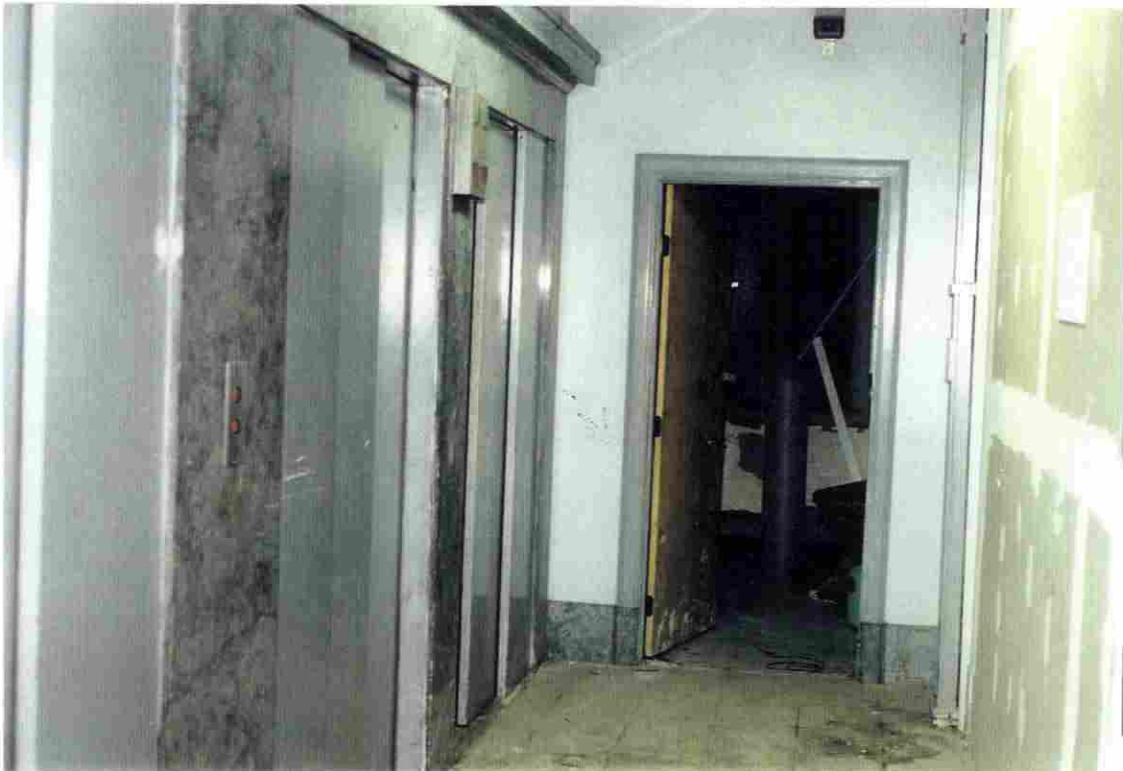
Security Building photo no.31
Mezzanine Level, Elevator walls
Historic marble wainscot .
West view
9-10-99

<p>Number 17</p>	<p>Architectural feature <u>Mezzanine Walls</u></p> <p>Approximate Date of feature <u>Non-original</u></p>	<p>Describe work and impact on existing feature:</p> <p>All existing gypsum wall board alterations to be removed. Extent of restoration of wall finishes and details to be determined after selective demolition.</p>
<p>Describe existing feature and its condition:</p> <p>Contemporary gypsum wall board partitions throughout.</p> <p>Photo no. <u>29-30</u> Drawing no <u>HP-11,HP-17</u></p>		
<p>Number 18</p>	<p>Architectural feature <u>Mezzanine Elevator Walls</u></p> <p>Approximate Date of feature <u>1926</u></p>	<p>Describe work and impact on existing feature:</p> <p>Existing Marble Wainscot to remain. To be patched, filled and restored as required.</p>
<p>Describe existing feature and its condition:</p> <p>Existing Marble wainscot in fair condition.</p> <p>Photo no. <u>31-32-33</u> Drawing no <u>HP-11,HP-17</u></p>

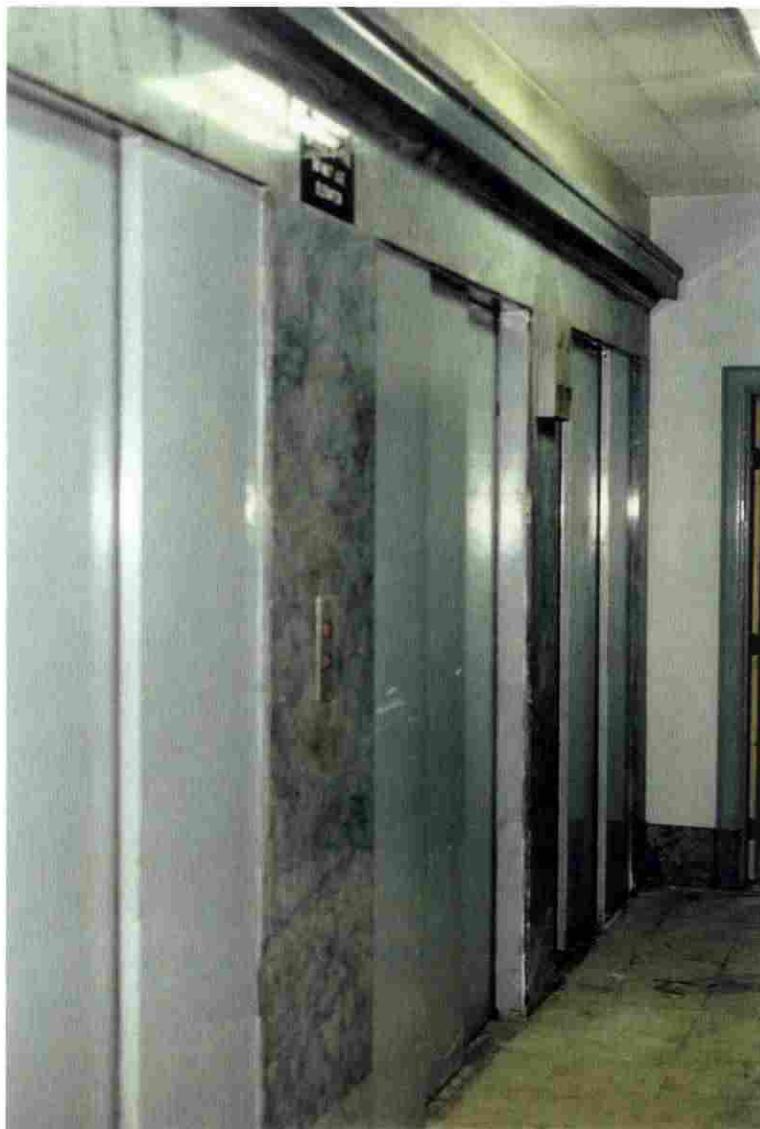
Security Building photo no.33
Mezzanine Level, Elevator walls
Historic marble wainscot and
Elevator doors.

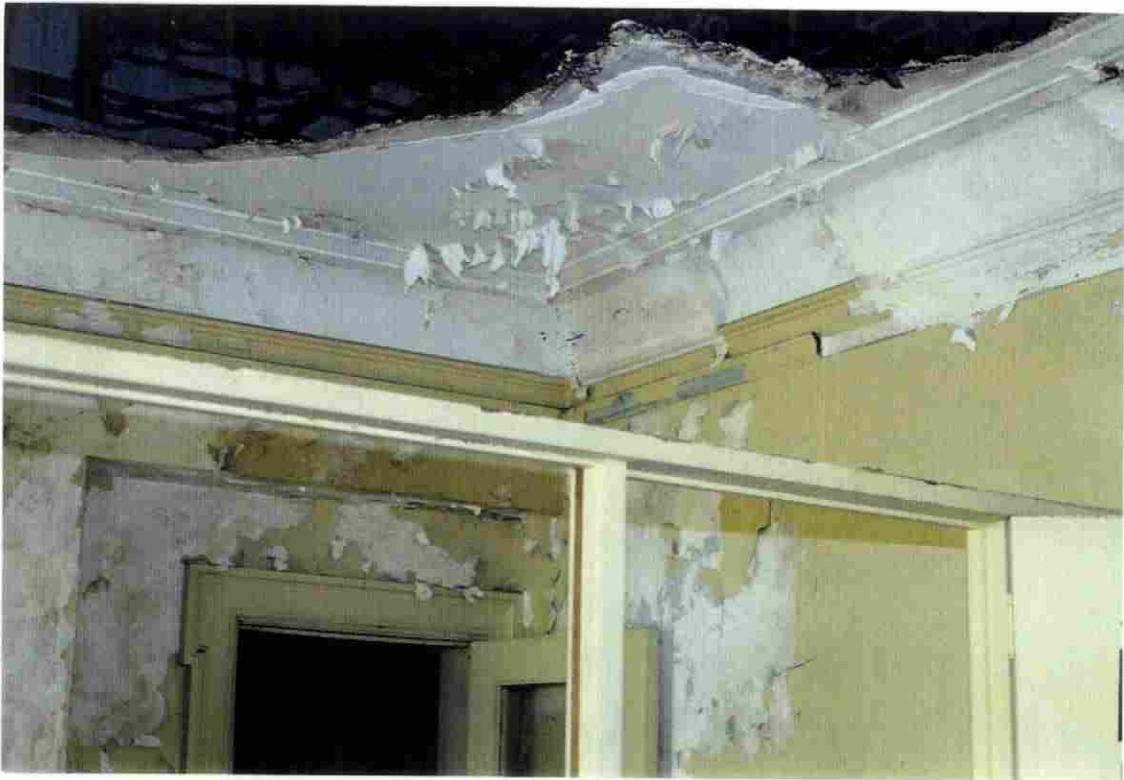
Security Building photo no.41
Mezzanine Level, Historic clg.
SE corner room.
9-10-99

<p>Describe existing feature and its condition:</p> <p>Metal Ceiling at Entry Lobby, Acoustical Ceilings throughout Ground and Mezzanine Levels. Original ceilings have been removed and moldings have been cut to allow for introduction of Mechanical systems, electrical conduits and sprinkler lines.</p> <p>Photo no. <u>17-18-19-20-21-36-37</u> Drawing no. <u>HP-10A,HP-11A</u> <u>38-39-40-41</u></p>

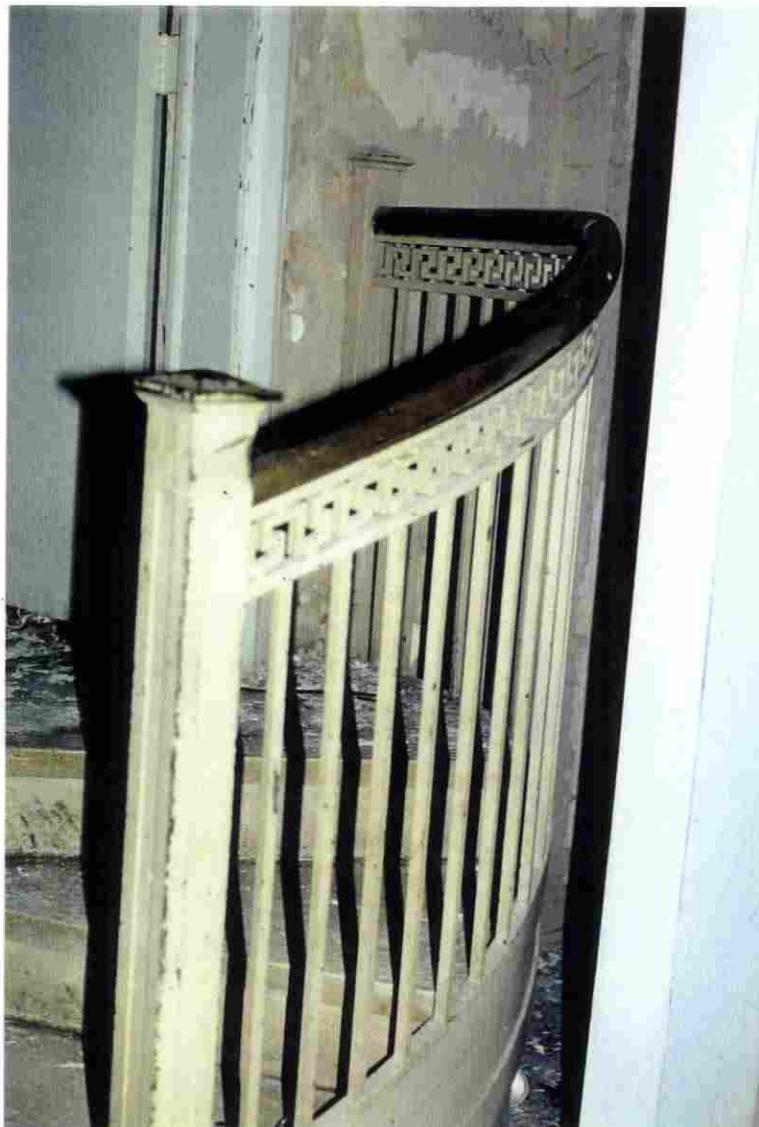
Security Building photo no.43
Mezzanine Level, Original stair
railing coming from room at NE
corner of mezzanine level.
9-10-99
